SI M52 01 13
Seats

Front Seat Lumbar Support Not Working

R60

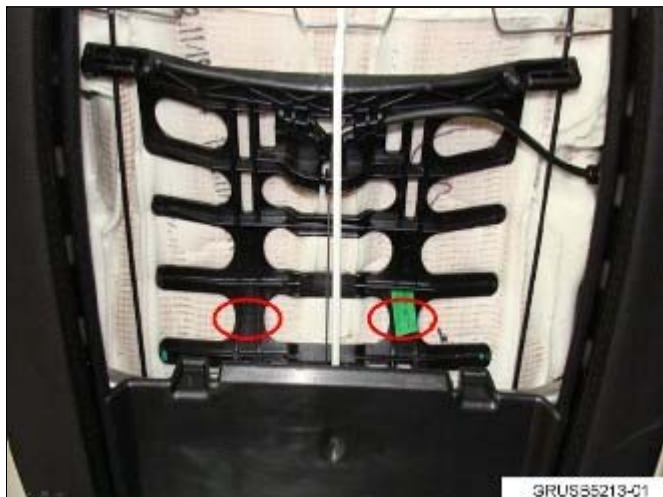
In most cases, the lumbar knob will rotate with limited or no movement of the lumbar support; this is due to a fractured or broken lumbar support.

The red circles in the photo below show where the breakage normally occurs.

If damage is seen, replace the affected lumbar support with the improved part.

Refer to ISTA Repair Instructions 52 13 055, "Remove and install/replace lumbar support on front seat."
