SI B64 01 13
Heating and Air Conditioning

April 2013
Technical Service

IHKA Operating Panel Buttons Are Peeling

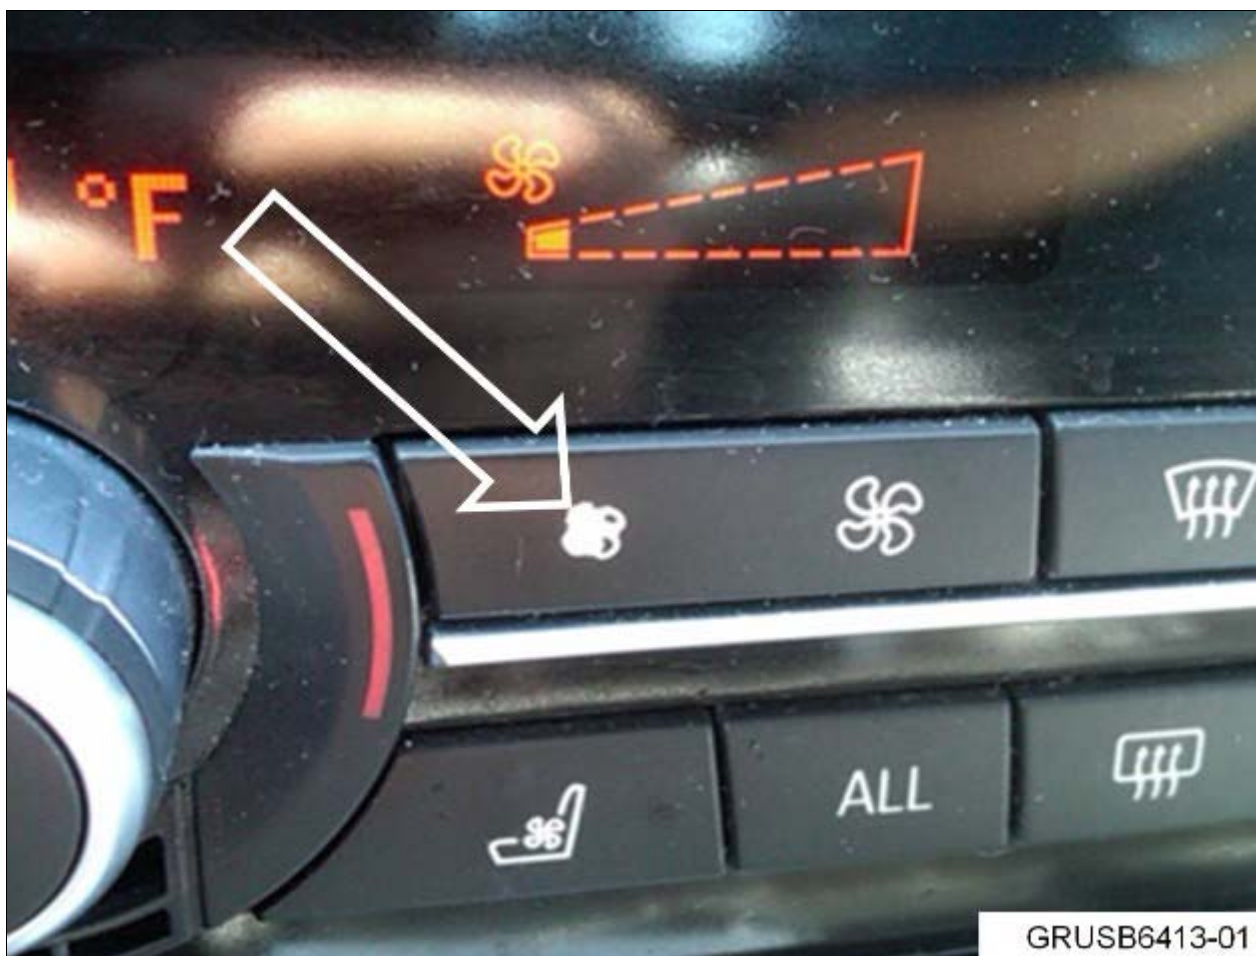
Ingredients in certain skin care products, including sunscreens and hand lotions, causes the button surface to peel.

In the picture below, you can clearly see how the low fan speed button is just starting to peel. Two of the four fan blades are missing from the button symbol, and soon the entire symbol will be gone.

Improved replacement buttons for the IHKA panel are now available as a kit.

Refer to ETK for the correct part number for your model. Replace **ALL** the buttons included in the kit.
