SI B12 08 13  
Engine Electrical Systems

May 2013  
Technical Service

**Service Action: Program Control Units (Auto Hold Response)**

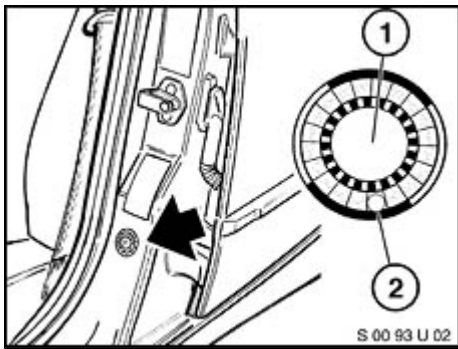
<p>This Service Action has been assigned code number <b>646</b>. After the vehicle has been checked and/or corrected, obtain a label (SD 92-420) and:</p>
--	---

- A. Emboss your BMW center warranty number in the middle of the label (1);
- B. Punch out code number **646** (2), printed on the label; and
- C. Affix the label to the B-pillar as shown.

If the vehicle already has a label from a previous Service Action/Recall Campaign, affix the new label next to the old one. Do not affix one label on top of another one because a number from an underlying label could appear in the punched-out hole of the new label.
