This Service Information bulletin supersedes SI B12 55 06 **dated January 2011**

N54: Diagnosis for DME FC 29DC/29F2/2FBF and Extended High-pressure Fuel Pump (HDP) Warranty Coverage

E90, E92 with N54 produced from 06/06

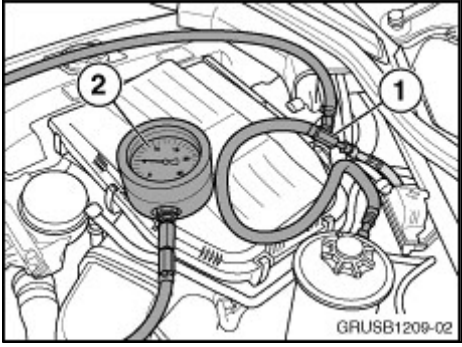
<ol style="list-style-type: none"> 1. Install a calibrated manual fuel pressure gauge (e.g., P/N 83 30 0 491 260 pressure gauge from the K-L-Jetronic special tool kit P/N 83 30 0 491 259), connected with the three-way adapter tool 135 270, into the low-pressure fuel supply line as follows: <ul style="list-style-type: none"> #1 – Three-way adapter tool (135 270) #2 – Pressure gauge P/N 83 30 0 491 260
--	---

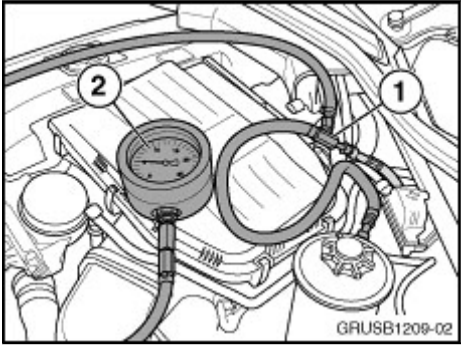
<ol style="list-style-type: none"> 2. IMPORTANT: perform this step ONLY FOR E89 (Z4) vehicles (not equipped with the low fuel pressure system sensor): Prior to execution of the High-pressure test module, install a calibrated manual fuel pressure gauge (e.g., P/N 83 30 0 491 260 pressure gauge from the K-L-Jetronic special tool kit P/N 83 30 0 491 259), connected with the three-way adapter tool 135 270, into the low-pressure fuel supply line as follows: #1. – Three-way adapter tool (135 270) #2. – Pressure gauge P/N 83 30 0 491 260
--	---
