SI B12 16 11
Engine Electrical Systems

March 2013
Technical Service

N55 Engine Failsafe - FC 120308 Boost Pressure Control, Plausibility: Pressure Too Low Stored in DME Fault Memory

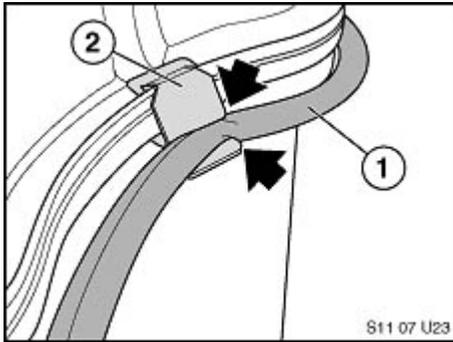
- Perform a quick inspection of all turbocharger boost control vacuum hoses; a slightly collapsed vacuum hose could lead to intermittent boost faults, or boost faults occurring only under heavy acceleration demands.

| | <ol style="list-style-type: none"> 1. Restricted vacuum hose 2. Retaining clip |

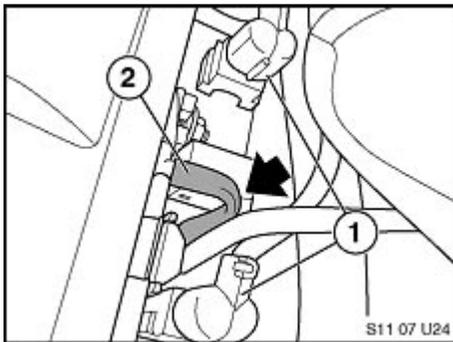
1. Vacuum solenoid
2. Kinked or restricted vacuum supply hose

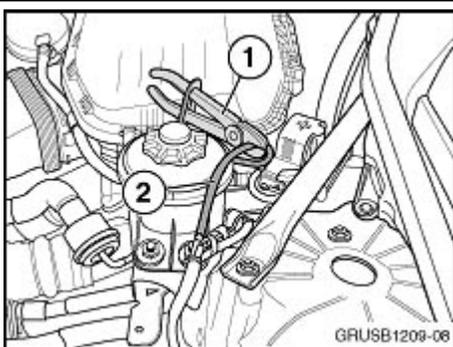
- Using a vacuum gauge can be very helpful in diagnosing a vehicle with intermittent boost faults. Although the problem may not be present long enough to set a boost fault, the gauge may show a hint of a deteriorating vacuum level that could ultimately lead to an effective repair. Connecting the vacuum gauge at the vacuum actuator with a “tee” connection will determine the integrity of the vacuum supply (compare values to the attachment). Erratic operation of the vacuum gauge is a hint that a control problem is present; comparing the gauge movement to another vehicle will help determine whether a problem is present.
- On models equipped with an exhaust flap, isolate or disconnect the vacuum supply to the exhaust flap to eliminate a leaking or a defective vacuum solenoid. This can be done very easily by blocking the hose located near the right front strut tower.

1. Suitable tool used to block the supply hose
2. Vacuum supply hose for the exhaust flap solenoid
