SI B17 01 13  
Cooling Systems

**Service Action: Replace Coolant Expansion Tank**

F30

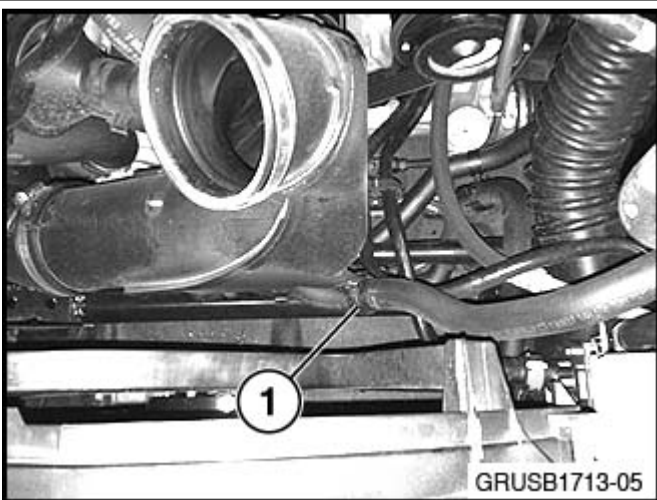
\*Note: Check for proper connection of the lower coolant hose from the expansion tank when removing/replacing the tank (1). The coolant hose may become disconnected during repairs. The hose will contact the engine cooling fan if this hose remains disconnected from the bracket. (Air box removed for clarity.)

Cut the replacement harness (from connector repair kit P/N 61 11 9 312 324) at 50 mm away from the taped portion of the harness (1). Crimp the new level sensor harness to the body harness with the provided cable connectors and heat shrinking hose (Refer to Repair Instruction 61 13 ... Butt connector for repairing a plug connection). Install the new coolant expansion tank.
