SI B51 06 13  
Body Equipment

**Driver's Door Mirror Adjustment Range Not Sufficient**

E84

F30

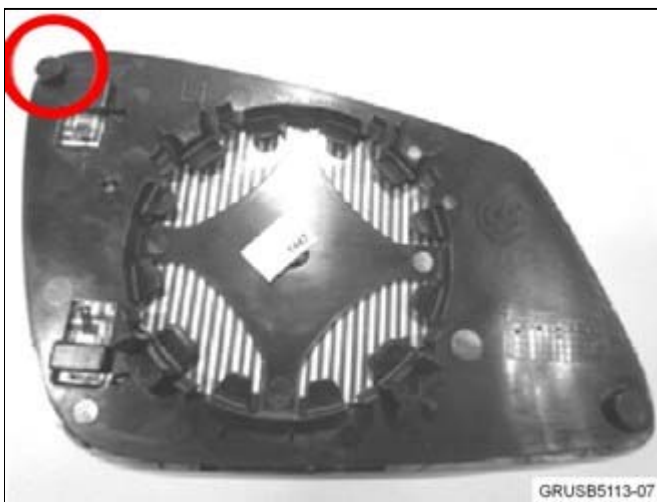
The mirror glass carrier inward bump stop is too high and limits the inward travel.

1. Place the removed mirror glass on a clean work surface. Locate the upper/inner plastic bump stop (red circle).
