SI B54 04 12
Special Roofs

Retractable Hard Top (RHT) Is Not Stacking Properly - Frame Bent

E93

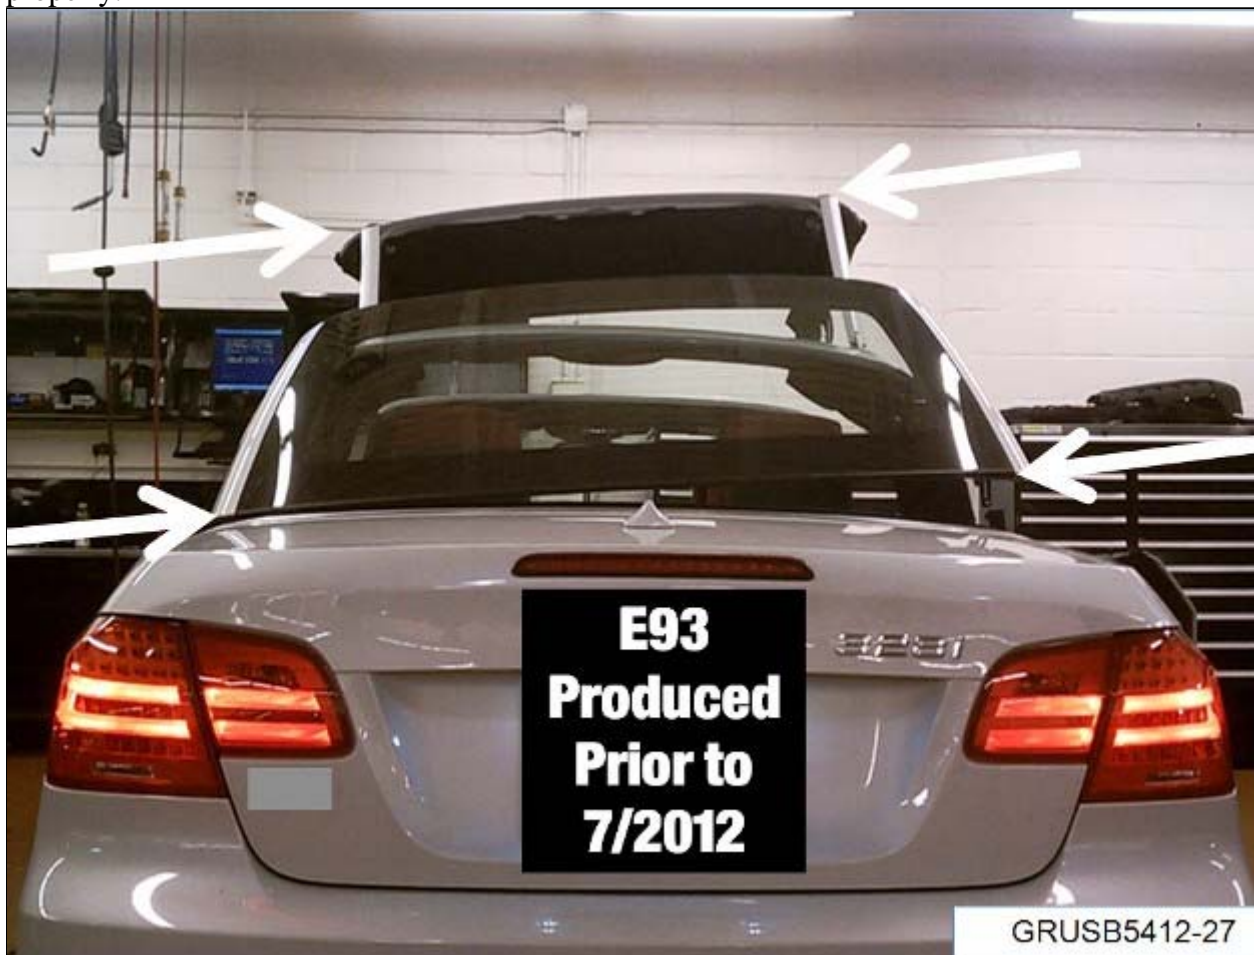
The RHT frame is bent or twisted and cannot be operated in either direction, or the roof shells are not stacking properly.

The hydraulic roof cylinders operate out of sequence causing the frame to twist.

1. Replace the complete roof module assembly.
