SI B61 13 12  
General Electrical Systems

**100A Fuse in Rear Power Distribution Box Failed, Causing Electrical System Failure**

F25 (X3)

Vehicles produced from October 31, 2010 to January 30, 2012

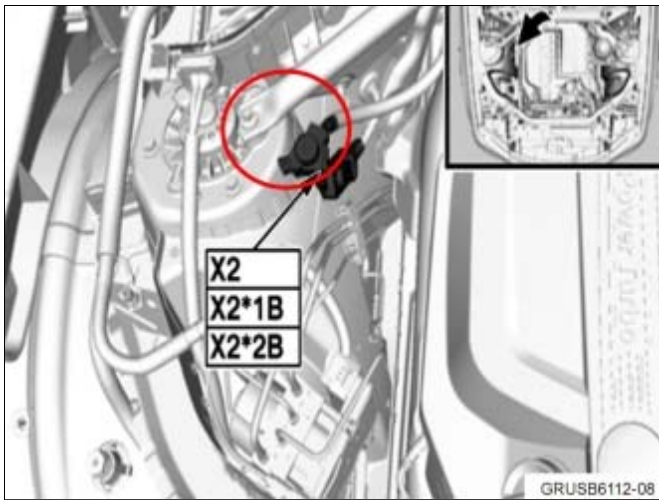
4. **X2 B+ Jump-starting point:** Check the metal brace located near the jump point terminal for signs of arcing. This can happen when jump-starting or the charging aid contacts the metal brace along with the terminal.

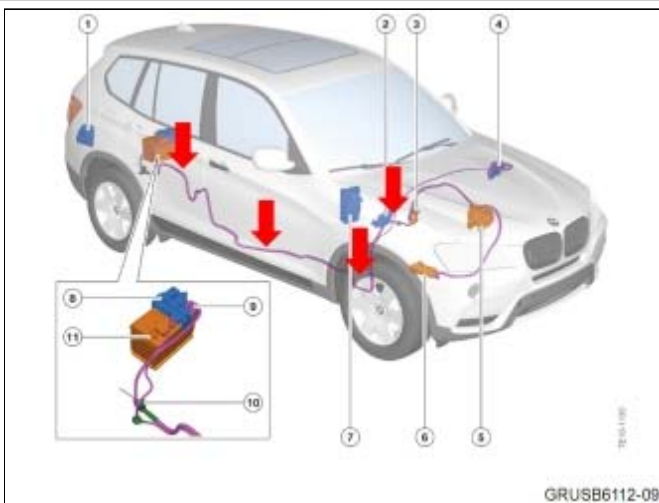
5. **B+ Battery cables that run under the vehicle:** Check the battery cables that run under the vehicle from the rear power distribution box up to the engine compartment for damage. This can be the result of underbody damage caused by an outside source. The diagram to the left shows the routing of the cable. If the cable is damaged, it needs to be replaced.
