SI B63 10 09
Lights

March 2013
Technical Service

Brake Light Bulb Failure

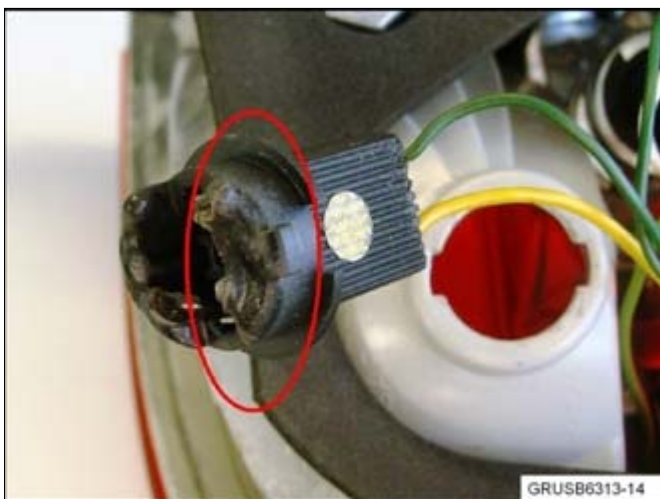
A Check Control message is displayed for brake light bulb failure. In some cases, inspection of the brake light bulb holder shows the molding for the bulb holder is deformed.

- Composition of the bulb holder material and high bulb temperatures
- Premature bulb failure
- Coding error in FRM (Footwell Module)
- Non-approved accessories or non-original parts (for example, aftermarket trail hitch or light bulbs)

2. Inspect the light bulb holder. If the bulb holder is black and damaged, it must be replaced with a new bulb holder (gray color with harness included). Replace the failed bulb with a long-life bulb 12V/16W (1 pair per side).
