SI B63 14 10
Lights

Rear Lamp Leaks

NEW E89

NEW Produced from January 31, 2009 to November 24, 2012

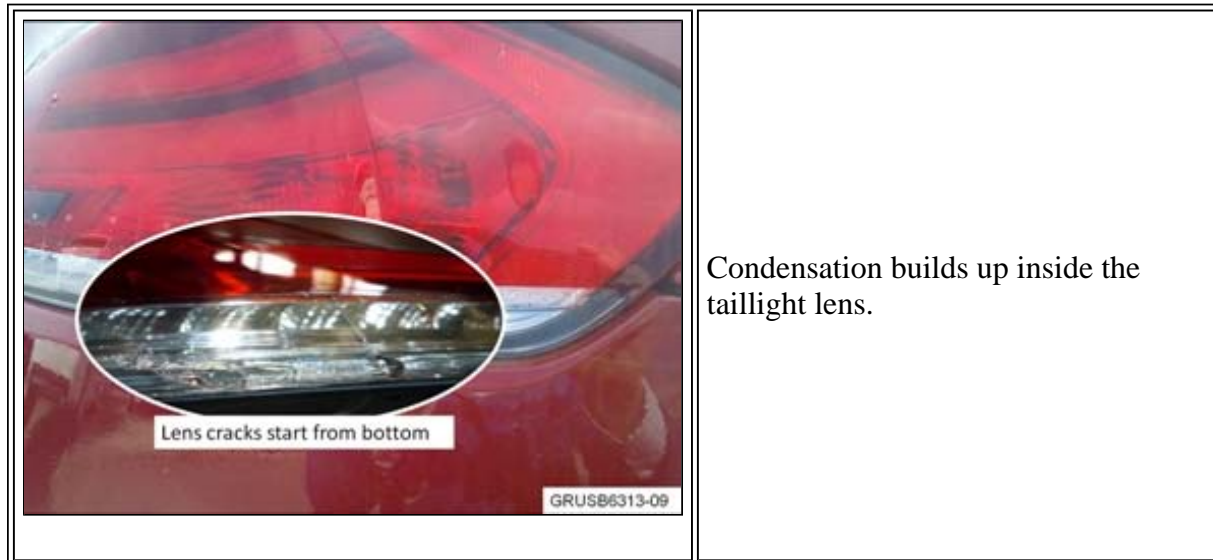
The rear taillight has cracks due to torsion stress (contact between the body and lens). The cracks provide a path for water to enter the taillight.

1. Inspect the rear taillight for any damage caused by outside influences or impact. Outside influences or impact is not covered under warranty
2. If no outside influences are found, replace the defective side taillight using ISTA Repair Instruction REP 63 21 170, "Removing and installing / replacing left or right rear light."
