SI B64 02 13
Heating and Air Conditioning

Water Leaks from Center Console

F25

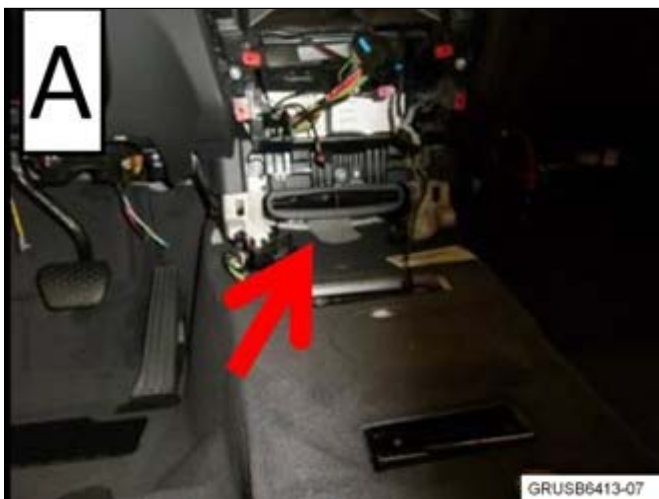
A. Remove the center console. Refer to ISTA Repair Instruction 51 161 55, "Remove and refit complete center console." The arrow shows the condensate drain in the center area of the housing.

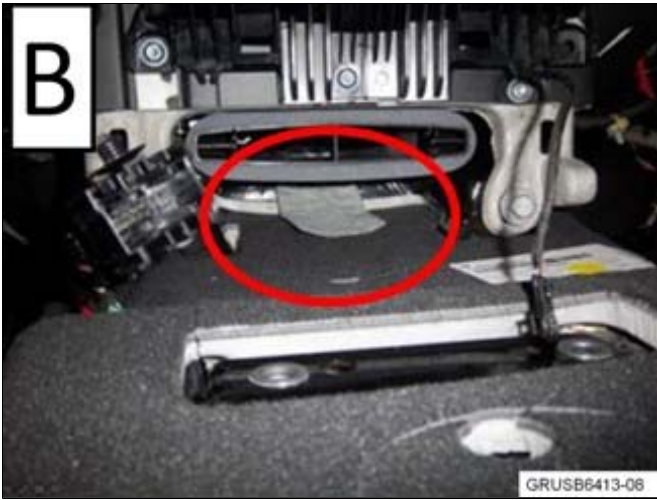
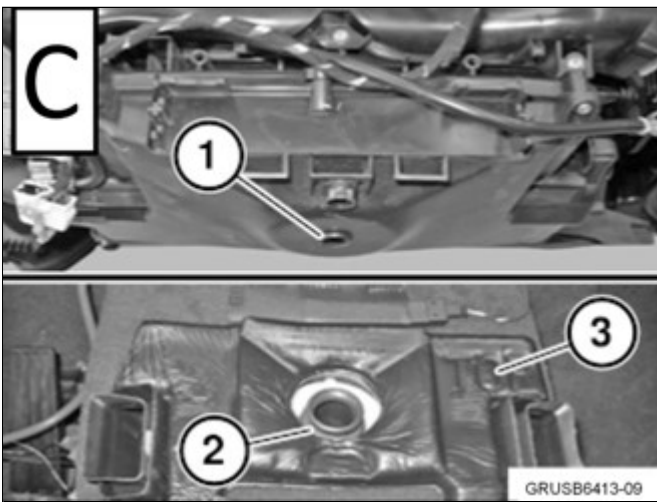
B. Visually inspect the condensate drain connection to the tunnel. Check the grey or black insulation mat to make sure it is not trapped around the housing drain or tunnel connection. If the mat is trapped, refit it properly. This can be done without removing the housing. Refer to Step D below for pictures of a proper drain fitment.

C. This picture from ISTA shows the location of the condensate drain with the housing removed.

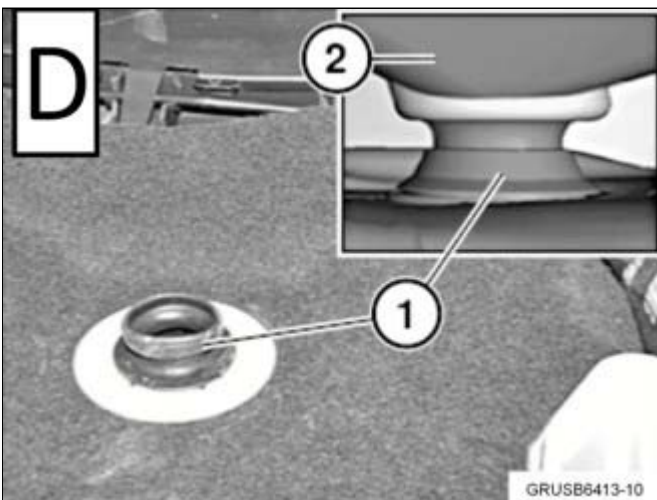
D. This close-up picture from ISTA shows the proper fitment of the drain in detail.

E. Run the A/C and make sure the drain is working properly prior to reinstalling the center console.
