**IHKA Control Panel Not Working**

E82

Produced from December 31, 2011 to September 20, 2012

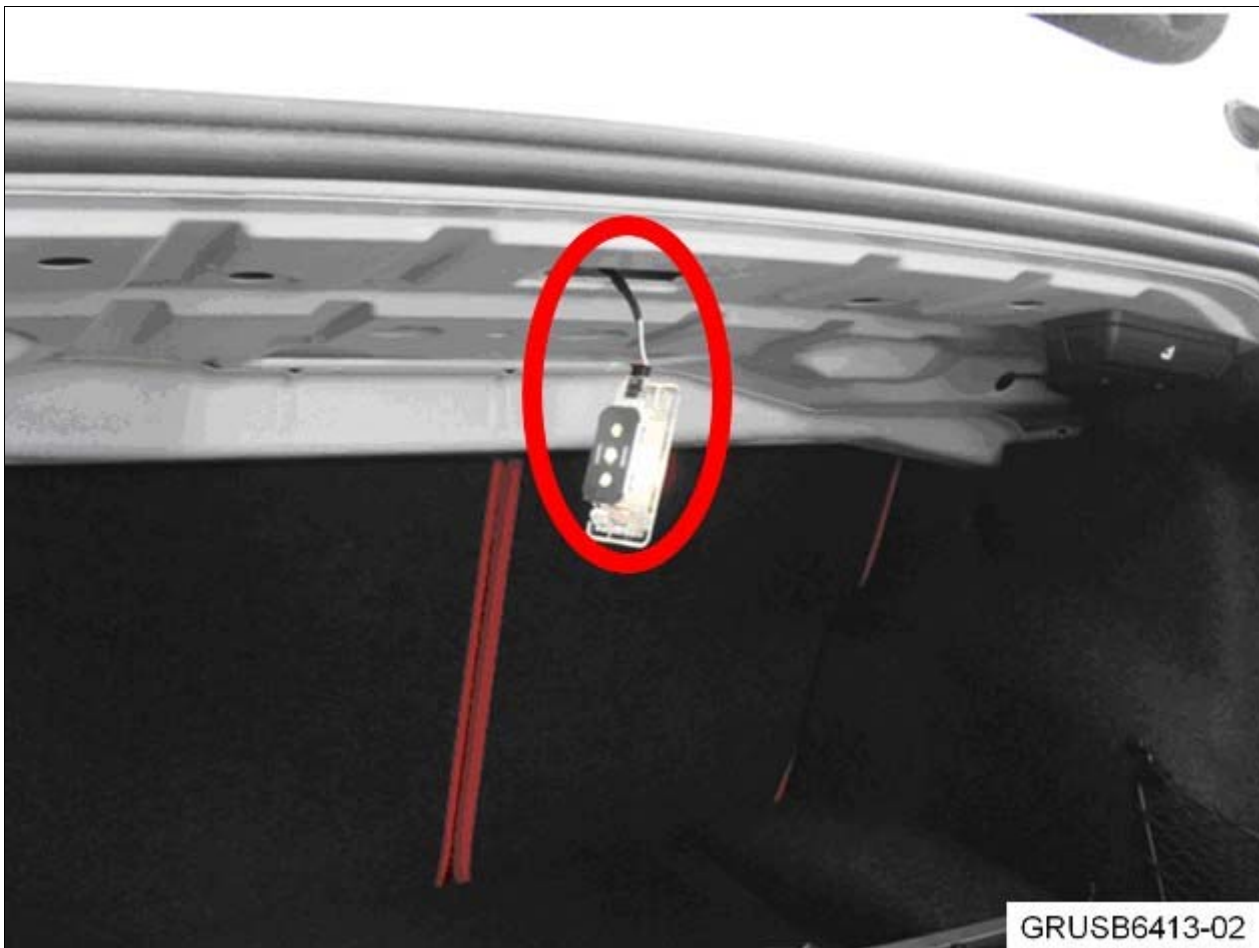
Fuse blown or chaffed wire for rear trunk light

See the picture below of a hanging light in the trunk.

2. Open the trunk lid and check if the rear trunk light is secure. If the light is hanging by its wire, check the wiring for any chaffing that could cause a short circuit to the body. Repair the damaged wiring as needed.
