PDC: Complete Failure of Front and/or Rear Sensors

F25

Produced to February 27, 2013 with option 508 (PDC -- Park Distance Control)

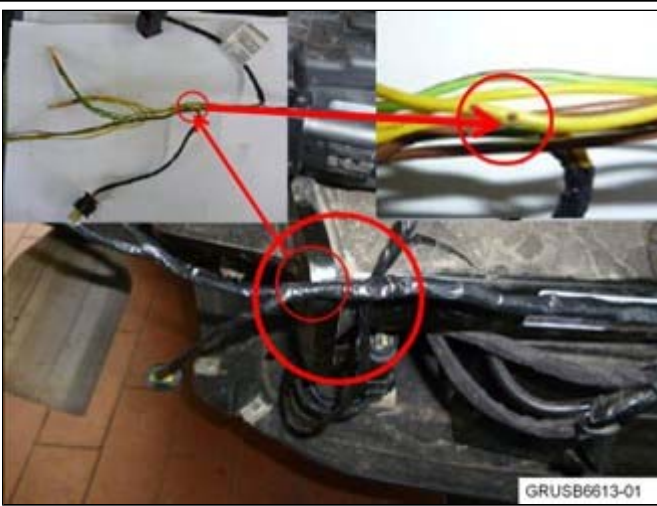
8. This picture shows a location where the rear PDC wire harness rubs against the trailer hitch if installed.

Note: This picture is a view of the left rear of the vehicle.

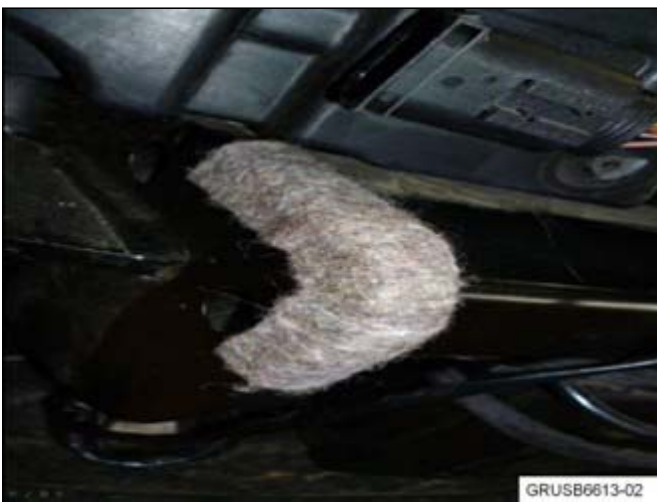
Note: The design of the trailer hitch may vary or differ from the pictures shown.

9. Apply felt strip to the trailer hitch in the location where the PDC wire harness rubs against the trailer hitch.

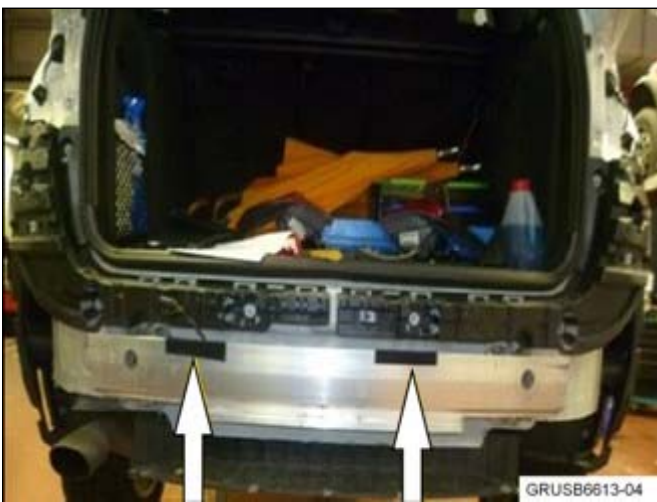
Note: This vehicle does not have a trailer hitch installed.

13. The arrows point to two locations where the PDC wire harness could be damaged.
14. Install felt strip on the bumper bracket as shown.

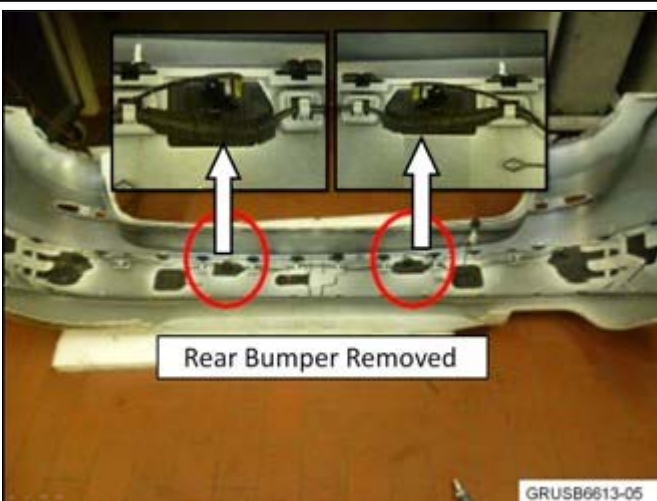
15. The arrows point to two locations where the PDC wire harness on the bumper could be damaged.
16. Wrap the wire harness using felt to prevent future damage.
17. Reinstall the bumper and verify the functionality of the PDC sensors.
