SI M51 02 13  
Body Equipment

Active Rear Spoiler Does Not Retract

R58

Produced from July 3, 2011 to October 28, 2012

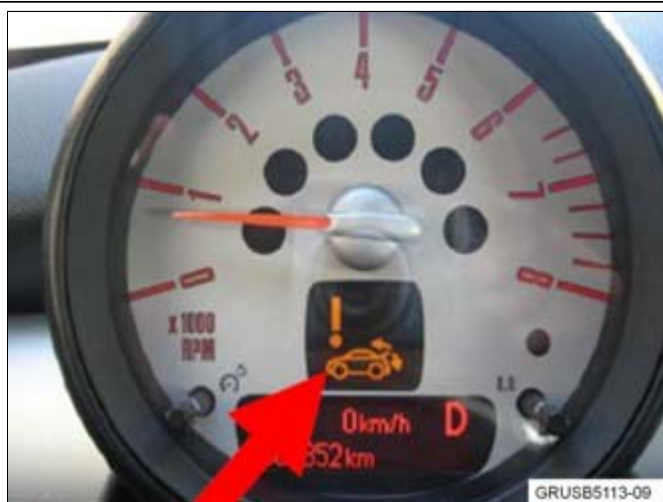
1. A check control message is displayed for a rear spoiler malfunction.

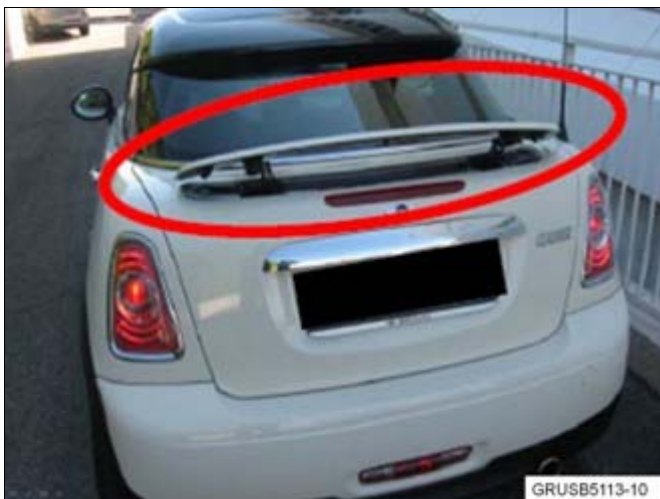
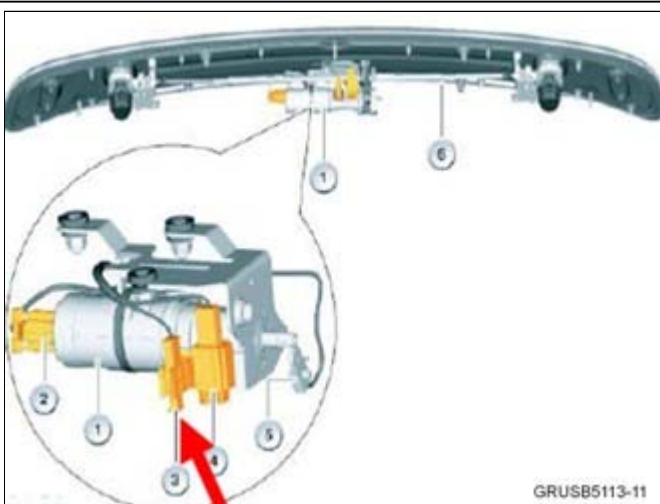
2. The rear spoiler has not fully retracted. It may be stuck in the full upper position or midway.

3. Check all electrical connectors at the rear spoiler drive.

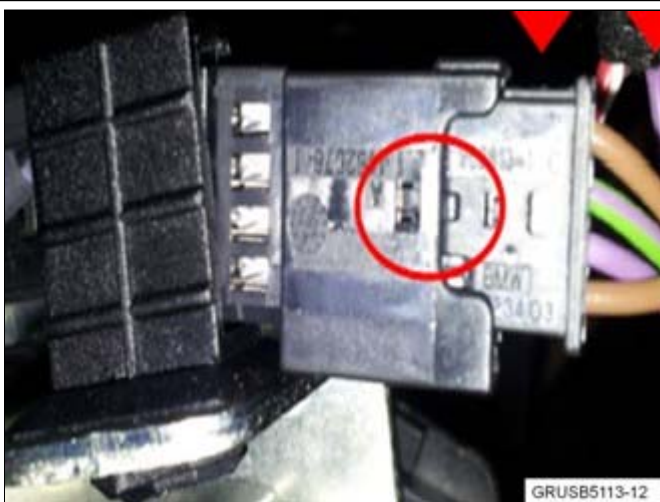
Loose wiring connector at rear spoiler drive motor

4. This close-up picture shows the 4-pin connector is slightly tilted and not fully inserted and locked in. The circle shows where the connector locking tab is located.
