US 53826242-01

Swinging arm gaiter to gearbox is split or collapsed

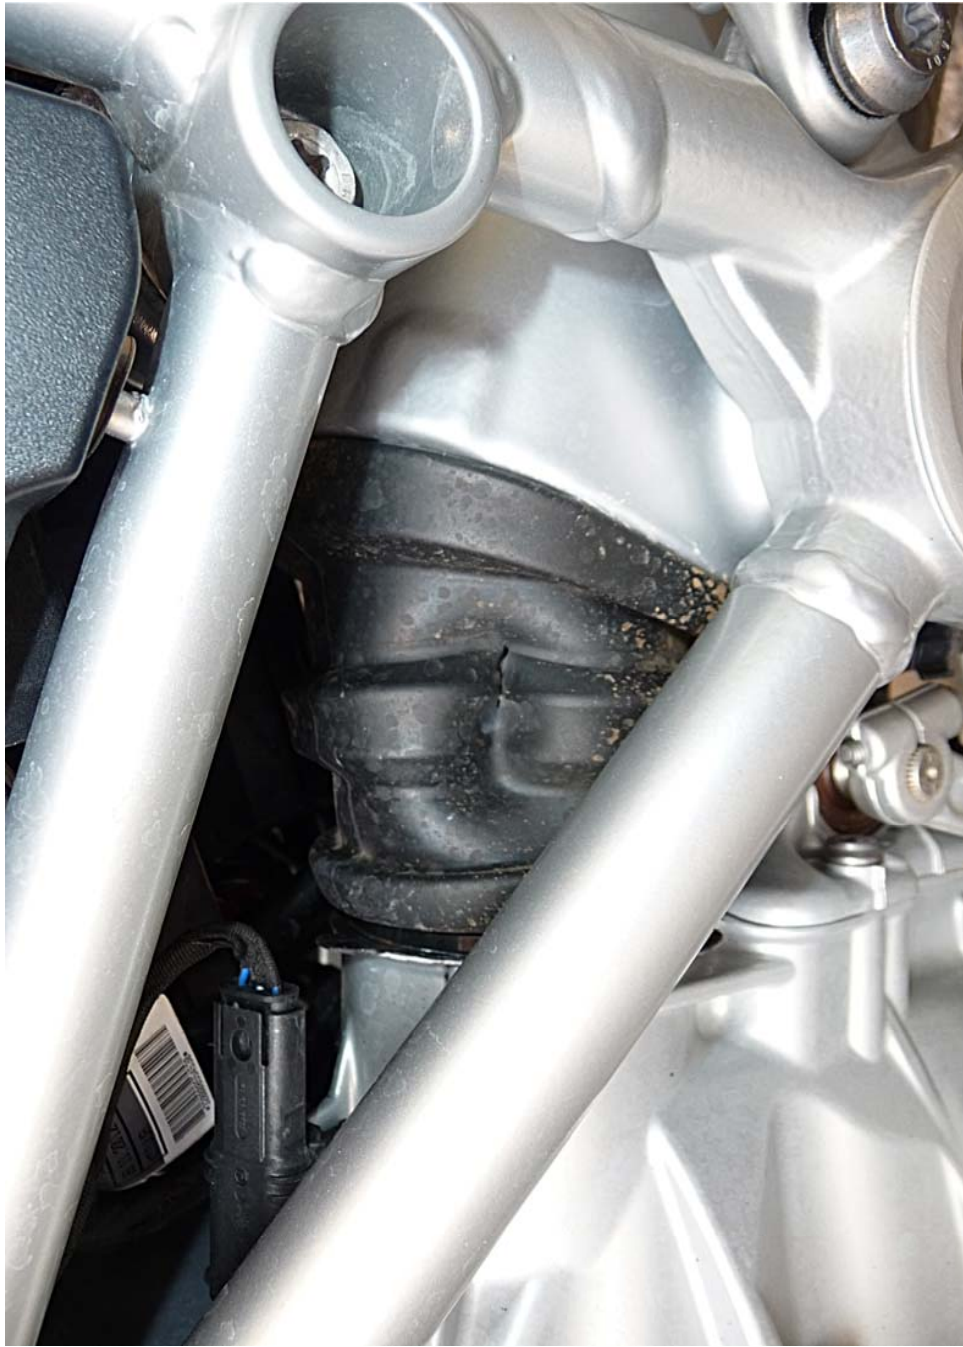
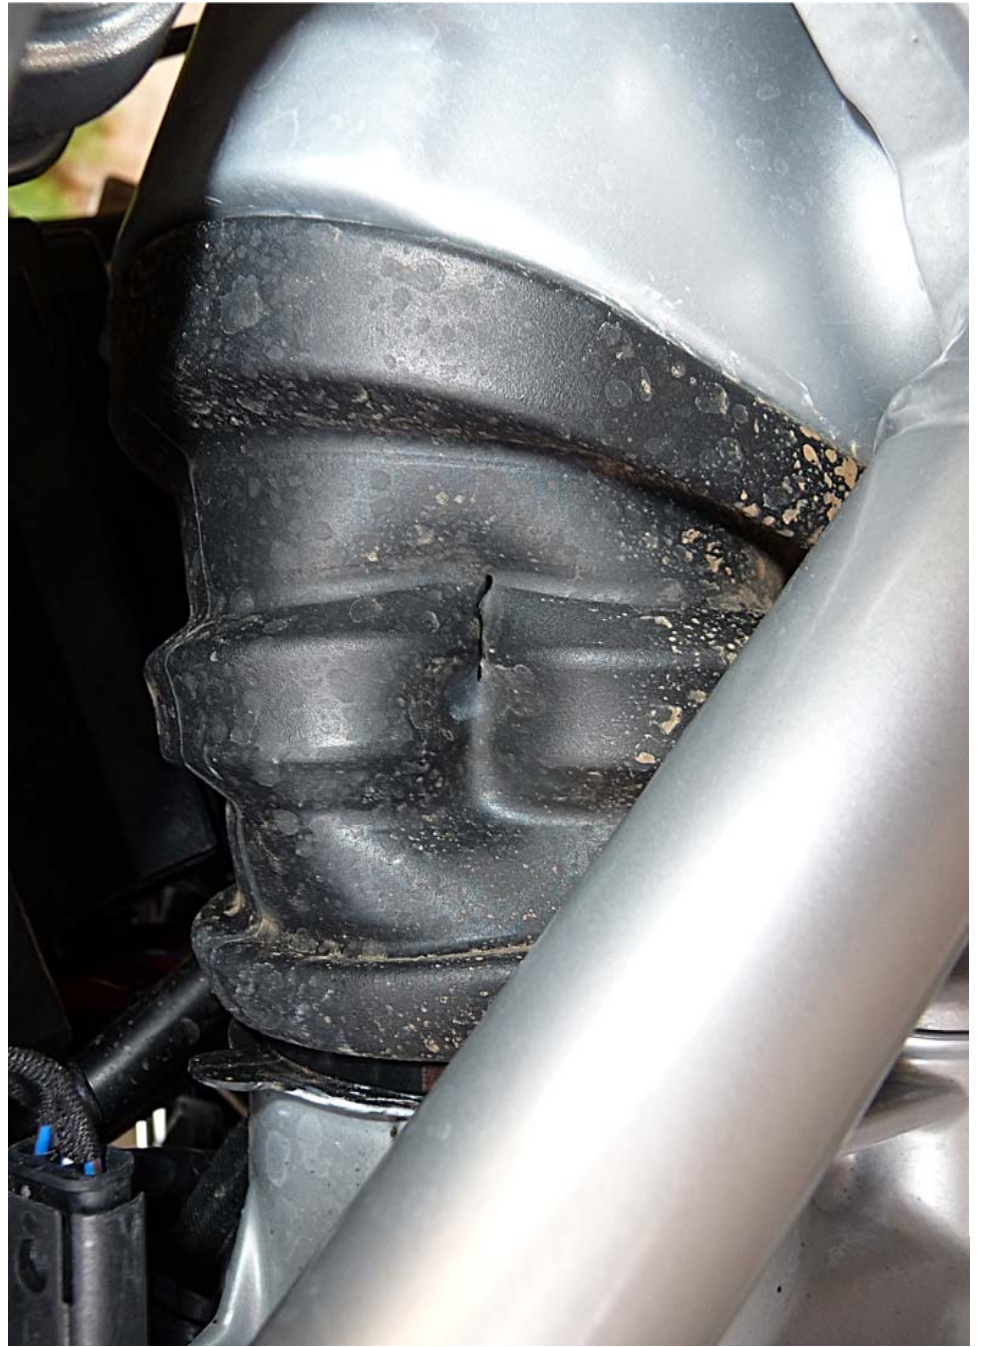
The gaiter between the swinging arm and the gearbox is split or collapsed (see attached photos).

The swinging arm gaiter material is insufficient.

If a swinging arm gaiter on the gearbox side of a vehicle is split or collapsed, the gaiter must be replaced. The latest version of this component is significantly improved and no longer tends to collapse.
