## BMW Motorrad USA

### Service Information Bulletin

**Subject:** Chafing of wiring harness

**Models:** S 1000 RR (K46), S 1000 RR (K46/11), HP4 (K42)

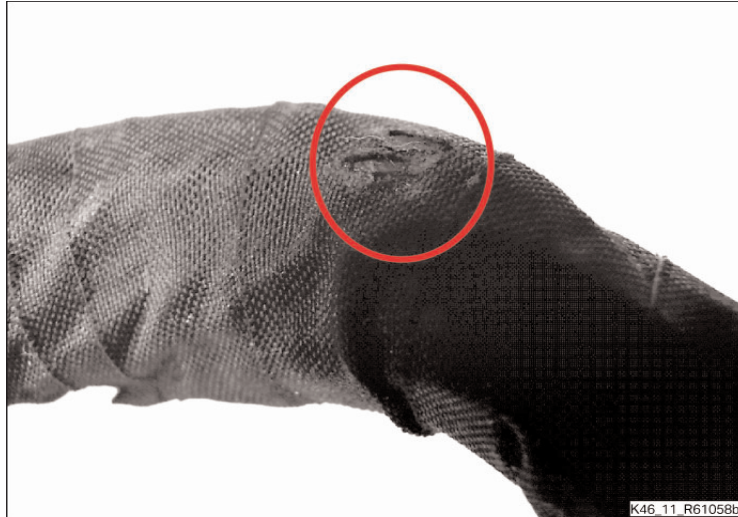
It is very important to examine the wiring harness closely at the points of contact; expose the wiring if necessary. Chafing often affects only very small areas.

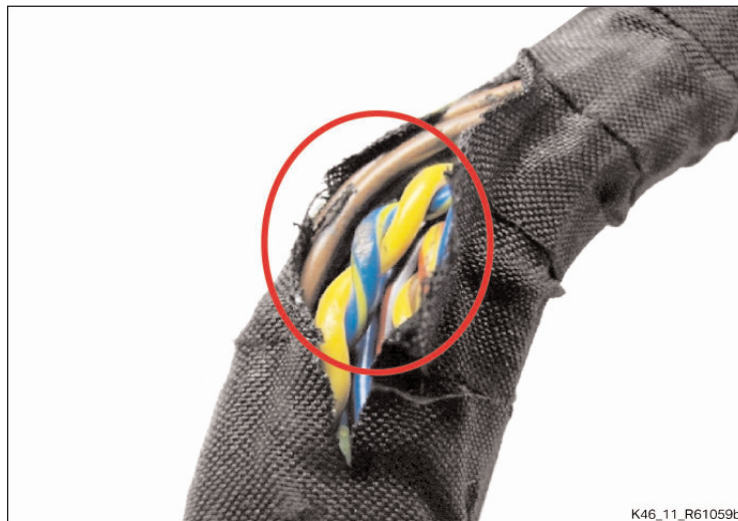
If the cable color cannot be identified at the chafing point: carefully open the wiring harness. If the color of the damaged wire for a component (component identification with the aid of the wiring diagram) and the fault symptom match, the cause has been found. If necessary continue the search for further chafing.

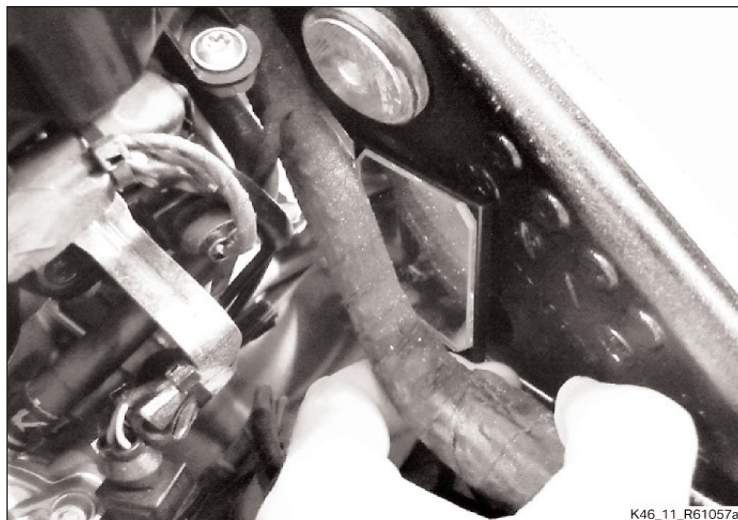
Use a mirror to examine the wiring in awkward locations (e.g. between intake silencer and frame)

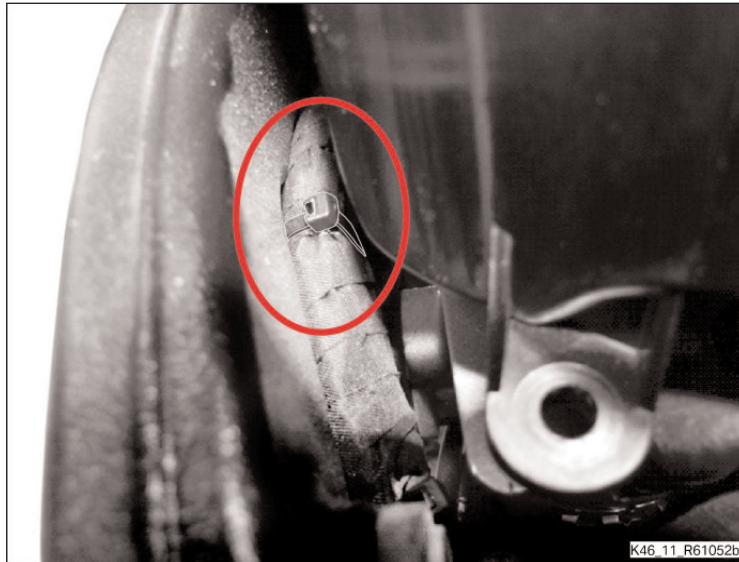
Chafing point on engine wiring harness (left side of vehicle)

In order to prevent the re-occurrence of chafing, wrap the area in question with several layers of genuine reinforced fabric adhesive tape (part number: 83 30 0 402 345) and pad it if necessary.

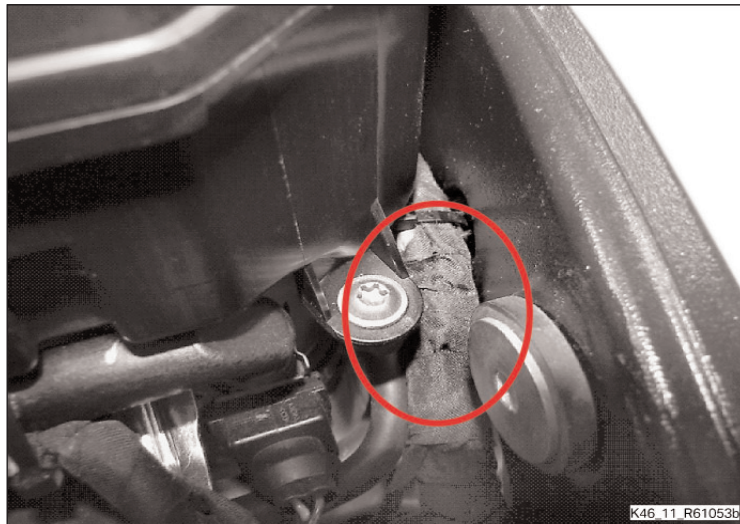
Chafing point on main wiring harness (right side of vehicle)
