**SUBJECT****A/C Cooling: Intermittent Reduction of Air Flow****MODEL**

F30

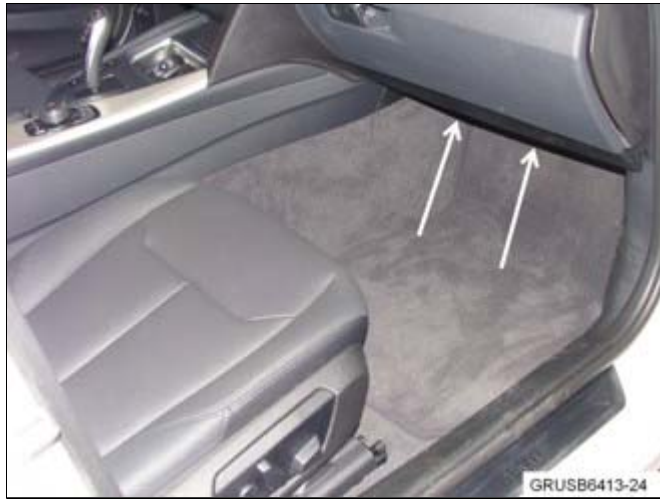
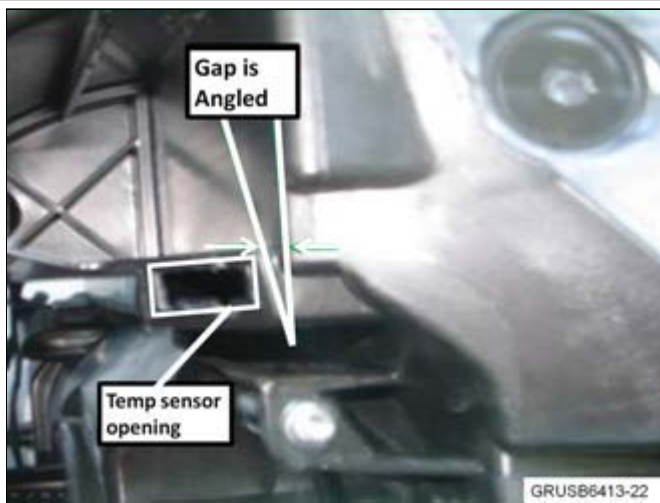
2. With the footwell panel removed, locate the evaporator temperature sensor opening (sensor removed for clarity). Note the gap between the sensor opening and the evaporator case. If the sensor opening contact surface is slightly angled as shown, this housing is **NOT** affected by this repair procedure. In this case, proceed with normal A/C diagnostic procedures.

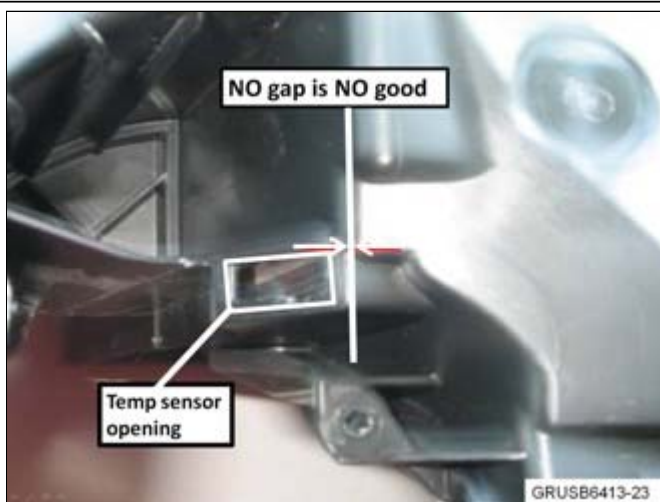
Evaporator starts to freeze up due to the position of the evaporator temperature sensor

3. If no gap exists and the sensor opening contact surface is not angled as shown, the IHKA housing is faulty. **Do not replace any parts until the retrofit adapter parts are available in early November 2013. This Service Information bulletin will be updated once the adapter parts are available.**

Until then, advise the customer this fault can be prevented by setting the A/C temperature to a slightly higher temperature setting and increase the fan speed to at least 2 bars.
