SI M54 02 13  
Special Roofs

**Convertible Top Rattles when Open**

R59

Produced from 3/1/2012 to 11/12/2012

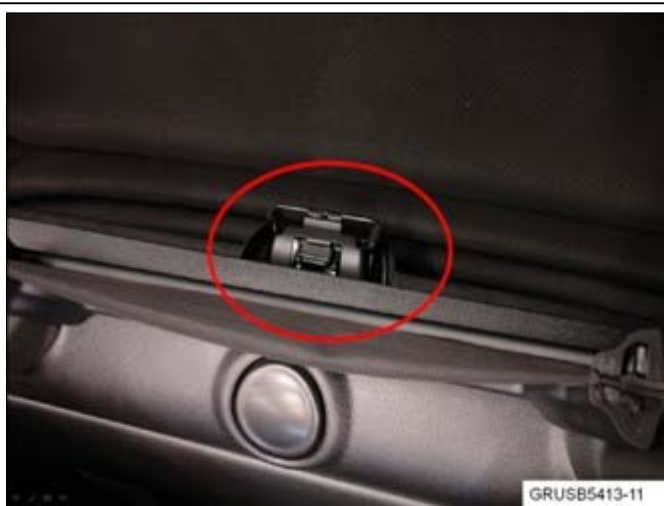
When the vehicle is in motion with the semi-automatic convertible top fully open or stowed, a rattling noise is heard in the rear center of the vehicle. The convertible top is resting on the locking hook.

The convertible top knocks against the locking hook when driving over uneven or rough pavement.

2. Locate the locking hook (shown in the picture).
