**N63T: Drive Malfunction Message with Rail Pressure Sensor Fault Stored**

With the N63Tengine

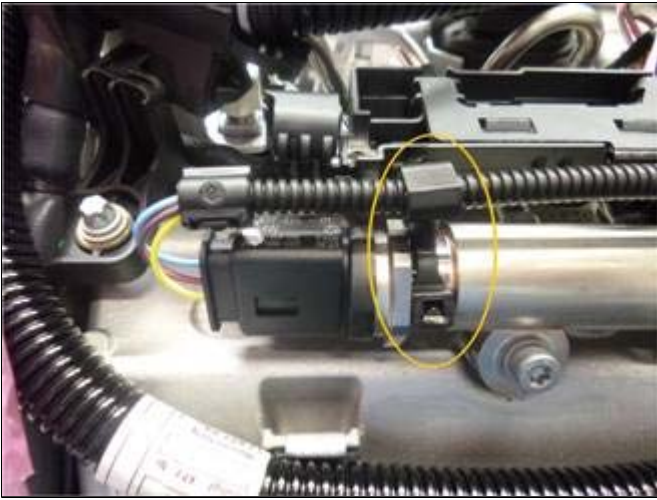
A poor electrical connection between the rail pressure sensor and engine harness due to vibration

Disconnect and reconnect the connector a few times and then secure the harness to the fuel rail, using a special harness cable tie. Repeat this procedure for the sensor harness on the other bank.
