SI B17 02 12  
Cooling Systems

**Low Coolant Warning Is Displayed**

F30 with the N20 or N26 engine

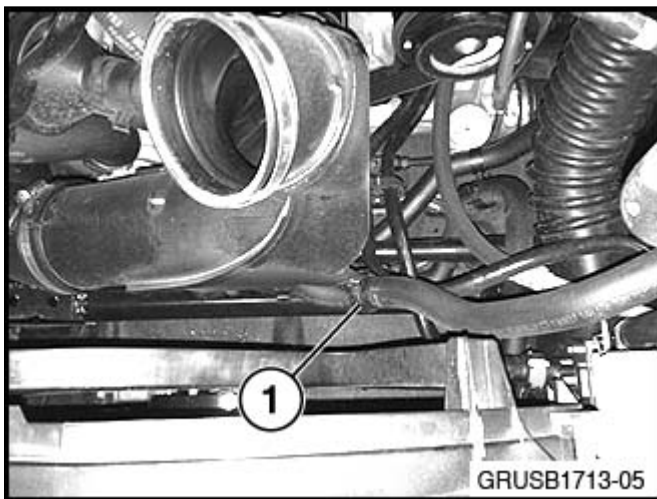
\*Note: Check for proper connection of the lower coolant hose from the expansion tank when removing/replacing the tank (1). The coolant hose may become disconnected during repairs. The hose will contact the engine cooling fan if this hose remains disconnected from the bracket (air box removed for clarity).
