SI B51 15 13
Body Equipment

Rattling Noise in the Front Door

F34

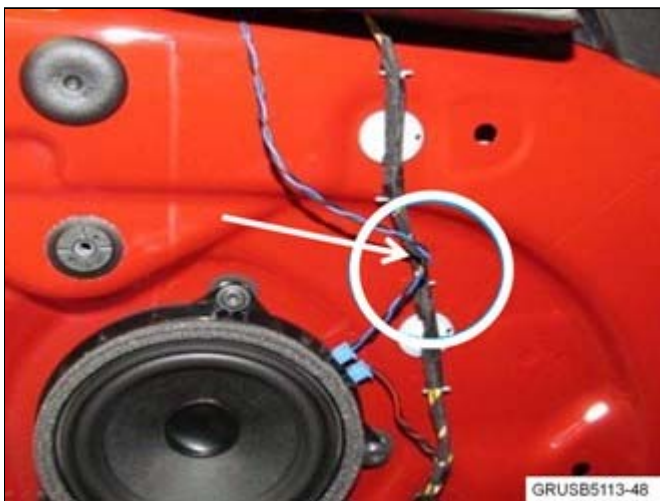
The wiring harness near the tweeter is not routed correctly.

Refer to Repair Instruction 51 41 000 and remove the affected front door panel. Check the routing of the upper tweeter wire. The wire must be wrapped around the main harness to prevent noises. If the wire is not wrapped, remove the upper wire from the tweeter and wrap it around the main harness once, and then reattach the wire to the tweeter. Reattach the door panel in the reverse order of removal and test drive the vehicle to confirm the noise has been eliminated.
