This Service Information bulletin supersedes SI B65 10 13 **dated March 2013**.

Enabling and Replacing New OC3 Seat Mat

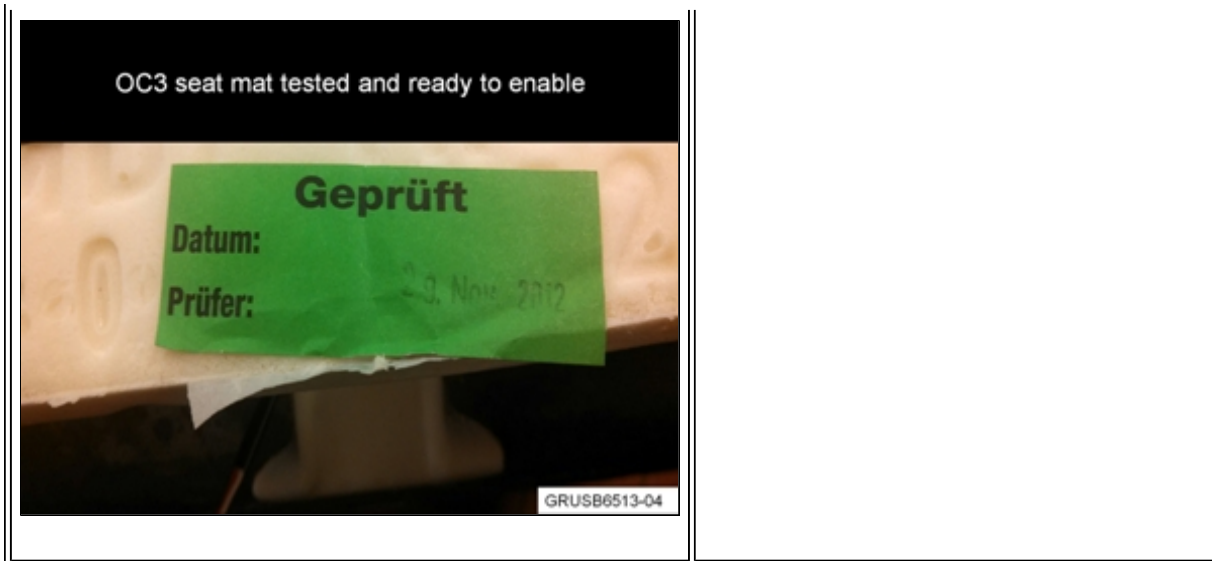
<p>Inspect the new part prior to installation; you should have same label as shown on the spare part to the left. With this label, the OC3 seat mat is ready to enable by following the procedure below.</p>
--	--
