SI B65 11 13  
Audio, Navigation, Monitors, Alarms, SRS

October 2013  
Technical Service

**CIS Seat Mat Replacement**

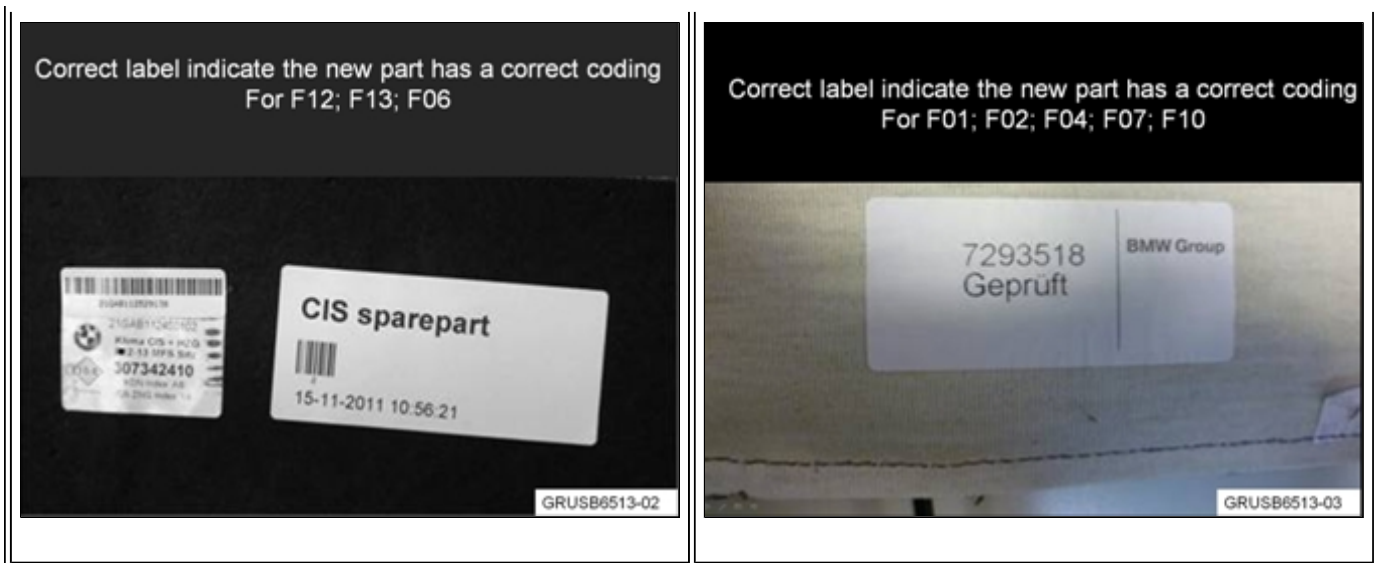
The pictures below are for a CIS seat mat that has the correct coding. The label should contain “CIS sparepart” or the German word “Geprüft” (tested).

Install the replacement CIS mat in the vehicle and code the ACSM (Advanced Crash Safety Module) with ISTA/P.

If the correct label is present; the new mat failed to enable; and the below faults are present, create a PuMA case for assistance. Make sure to attach a digital picture of the new seat mat to the case, as well as the original reason why the seat mat is being replaced.

If there is no label on the seat mat, reorder the new seat and submit a TTS PuMA case to the Parts Consultant Group, requesting assistance in obtaining the correct seat mat.
