SI M61 01 13
General Electrical System

July 2013
Technical Service

Battery Charge Condition Not Available in Energy Diagnosis

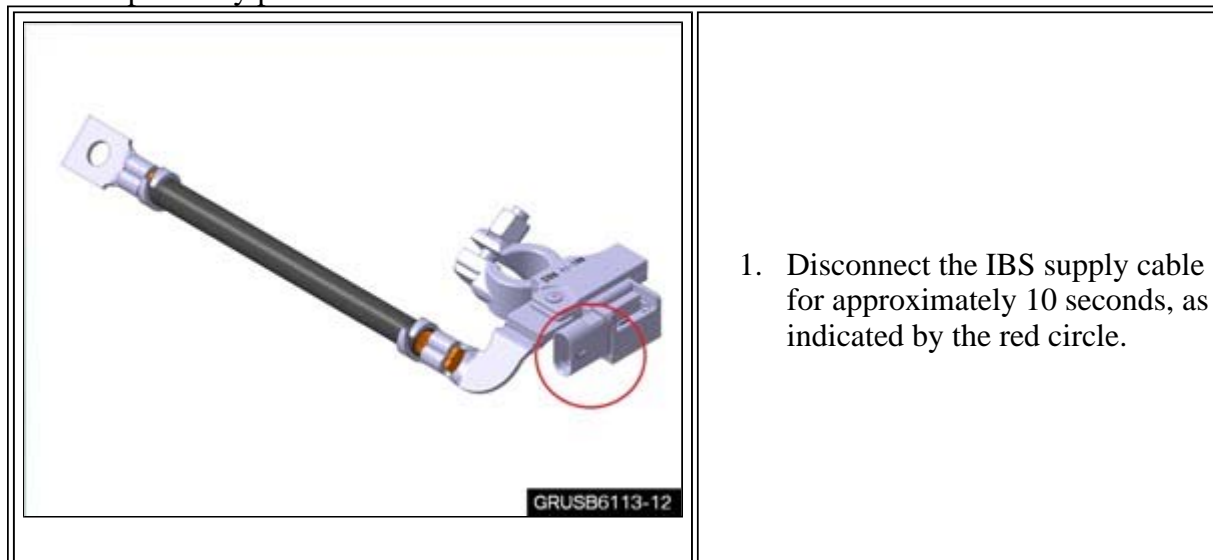
The power management system was not reset properly at the end of vehicle production, leaving the IBS in a fail-safe mode.

Do not replace any parts.

2. Reconnect the IBS supply cable and leave the vehicle parked and undisturbed for approximately 1.5 hours, in order for the IBS to perform the first charge condition check.

3. Energy diagnosis can then be performed, and the battery charge condition values read out.
