SI M11 05 13
Engine

October 2013
Technical Service

Service Action: N14 Engine Retrofit Turbocharger Engine Oil Supply Line Heat Shield

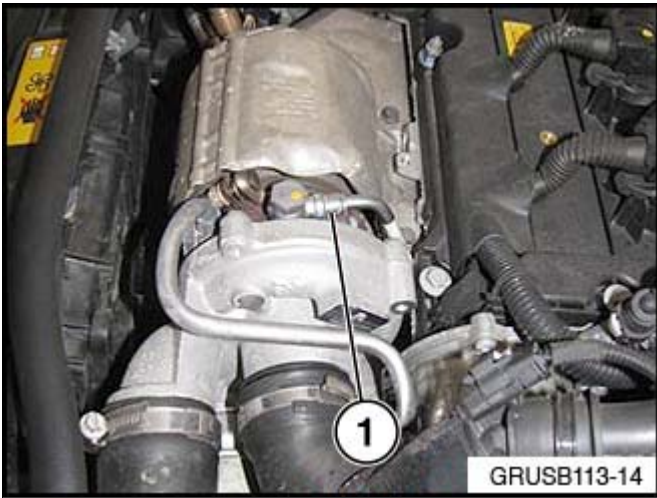
2. Example: The oil supply line is **not** fitted with a heat shield (1).

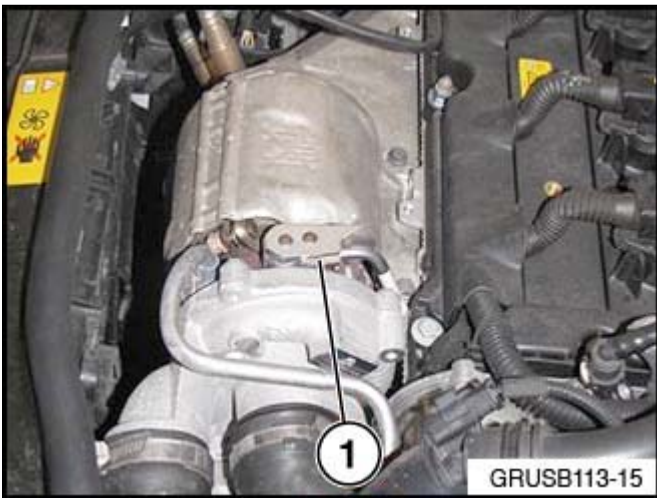
3. Example: The oil supply line is fitted with a small heat shield (1). Remove this heat shield and discard it.
