SI M33 01 12
Rear Axle

October 2013
Technical Service

Adjusting Rear Camber

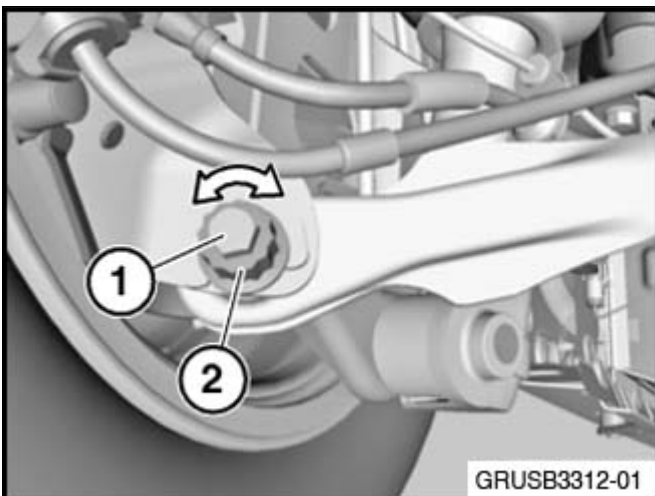
Rear camber cannot be adjusted properly.

Repair instructions not followed properly

Failure to follow these steps may result in damage to the adjustment bore in the rear trailing arm.

- Raise the rear axle (tire spin-free).
- Loosen the lock bolt (1).
- Turn the eccentric adjuster (2) to full positive (large portion of eccentric points down).
- Slightly tighten the lock bolt (1).
- Lower the axle and compress suspension.
- Slacken the lock bolt (1) and adjust the camber (2).

| | <ul style="list-style-type: none">• Tighten down the lock bolt. |

This procedure can be found in Repair Instruction 32 00 620, “Adjusting rear axle.”
