SI M51 05 13
Body Equipment

Creaking/Cracking Noise from the Upper Roof Area

R60

Produced from July 31, 2011

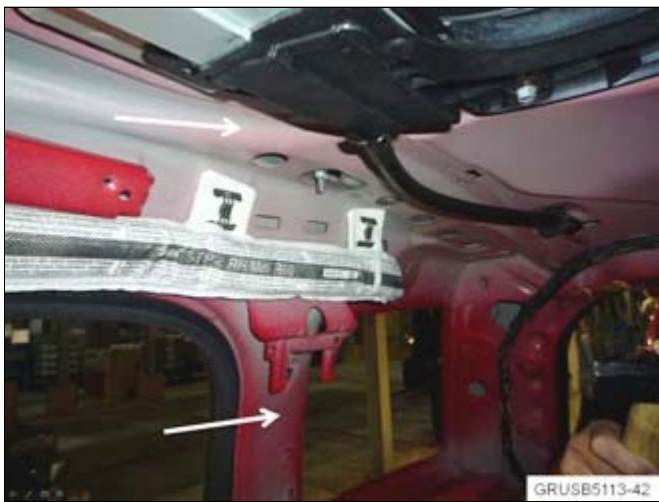
Confirm the location of the roof noise being generated at the upper area of the C-pillar, and proceed to the next step.

1. Remove the headliner and inner C-pillar trim from the affected side.

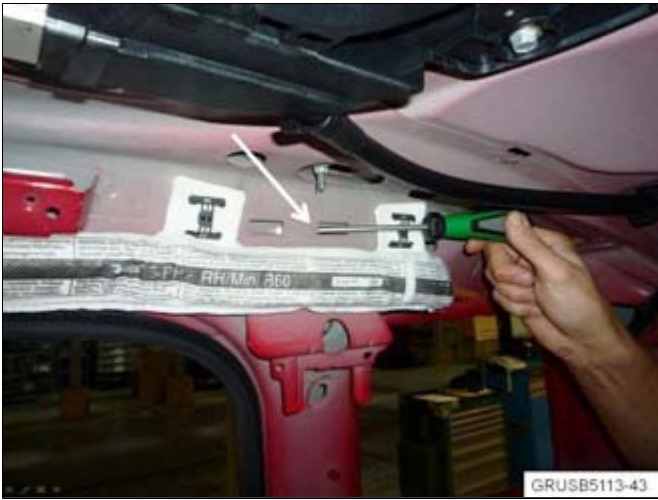
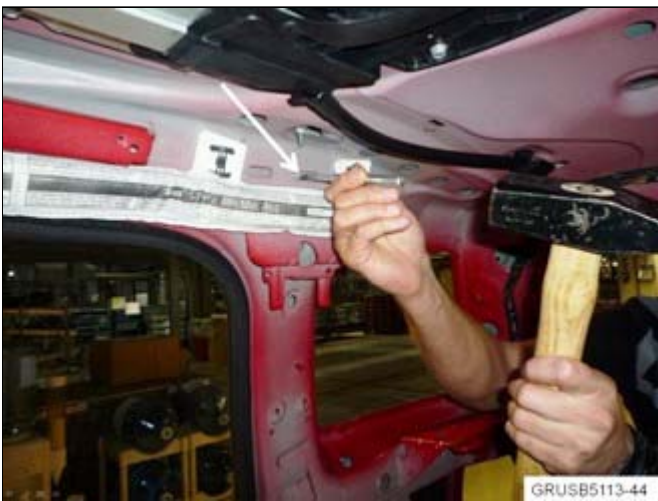
The body shell roof support area, where the C-pillar is joined to the roof, is buckling, creating the noise.

2. Road test the vehicle with a helper, inserting a screwdriver through the roof, and opening and applying varying pressure to the metal roof support as shown. If the noise can be eliminated by applying pressure, proceed to the next step.
