SI M52 02 13  
Seats

October 2013  
Technical Service

**Squeaking Noise from Front Seat**

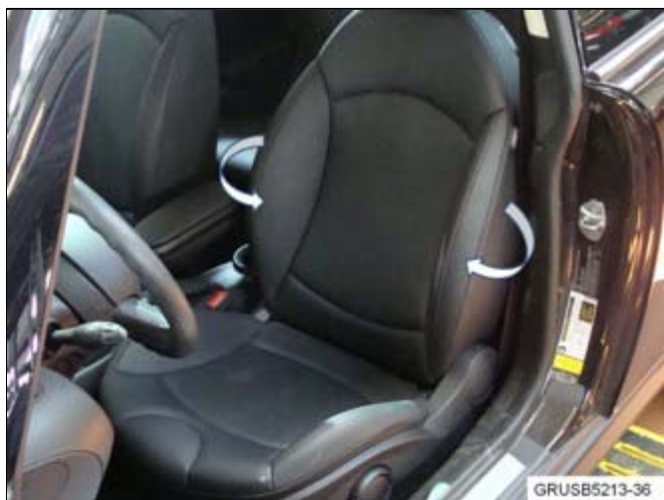
1. Duplicate the seat noise by moving the front seat back cover and padding left and then right. If the noise can be heard, proceed to the next step.

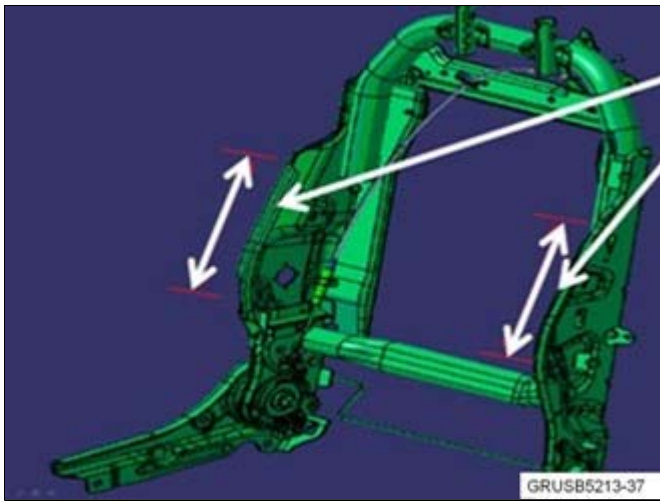
Surface corrosion on the metal seat back frame can make a squeaking noise when rubbing against the foam rubber padding of the seat back.

2. Refer to Repair Instruction 52 13 405 and remove the seat back padding, together with the seat cover, far enough to expose the surface corrosion on the metal seat back frame. The areas of concern are shown by the arrows.
