SI B51 09 13  
Body Equipment

September 2013  
Technical Service

**NEW** Door Springs into Pre-Locking Position

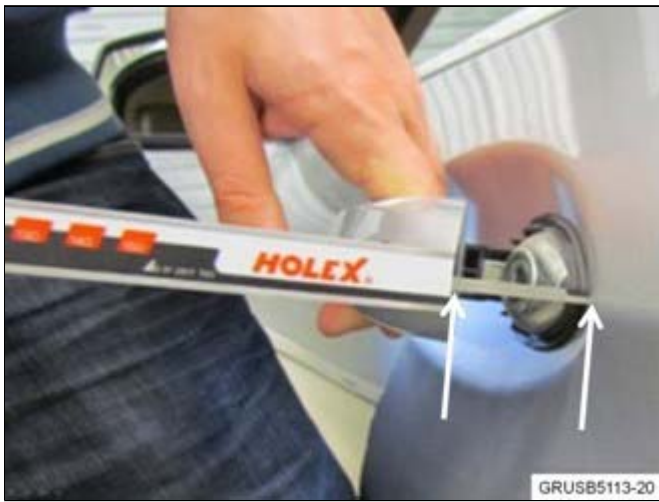
3. Close the front door and pull the outer door handle to the “trigger point” when the door first pops open. Measure the distance from the edge of the inside of the outer door handle to the metal door skin, as shown. The “trigger” distance should be between 24 mm-27 mm. Note: A scale or tape measure is physically too large to accurately make this measurement. A sliding caliper must be used for accuracy.

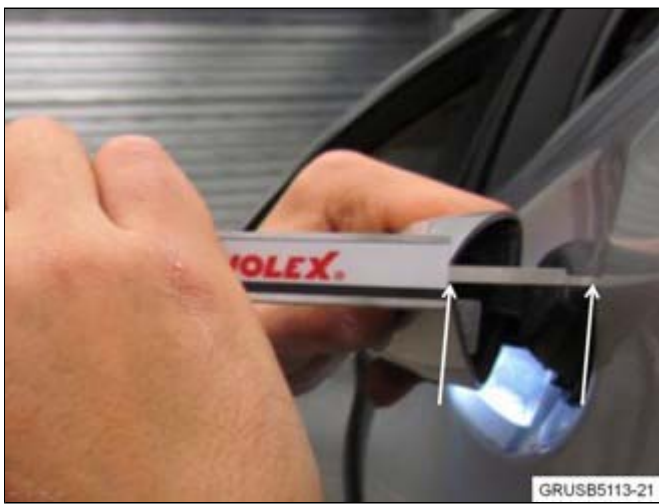
4. Use the same procedure in step 3 to measure the outer rear door handle. The “trigger” distance should be between 24 mm-26 mm.

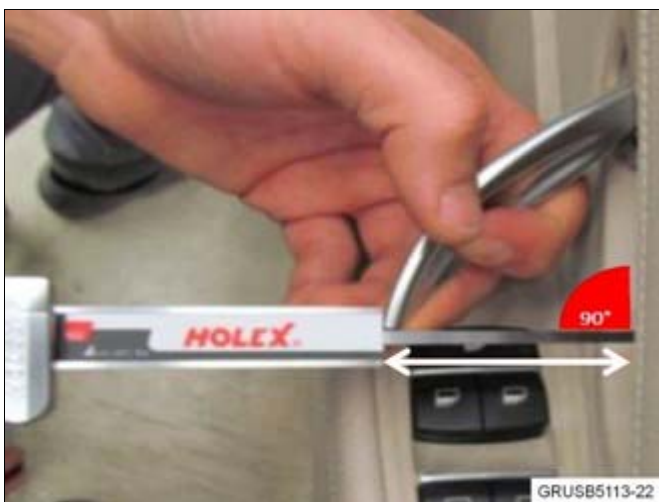
5. Repeat the measurement procedure for the front inner door handle. Measure the distance from the edge of the inner door handle to the inside trim pocket, as shown. The “trigger” distance should be between 65 mm-68 mm. Maintain a 90-degree angle to the door pocket when making this measurement. Always perform your measurements with a sliding caliper, and keep the measurement tool square to the door.

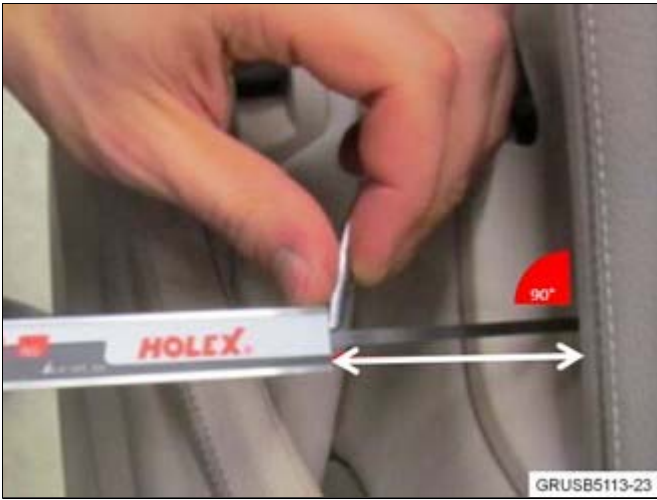
6. Repeat the measurement procedure for the rear inner door handle. Measure the distance from the edge of the inner door handle to the trim pocket, as shown. The “trigger” distance should be between 78 mm-80 mm.

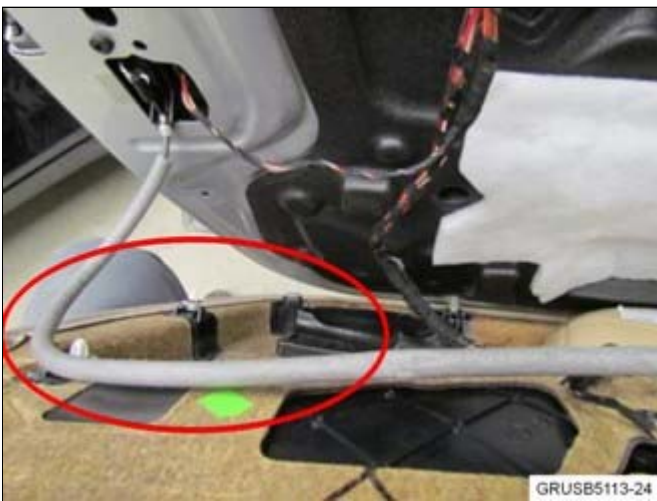
8. Check the Bowden cable routing of the inside door handle. This picture shows the cable being routed **incorrectly** in the upward direction. This will create pretension of the cable to the lock.

9. The cable must be **correctly** routed in a downward direction from the door handle, and then in an upward loop to the door lock. This type of routing allows smooth tension-free operation of the cable.

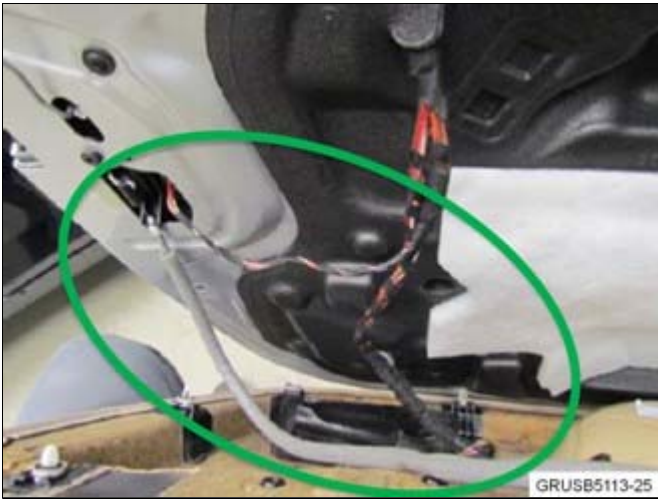
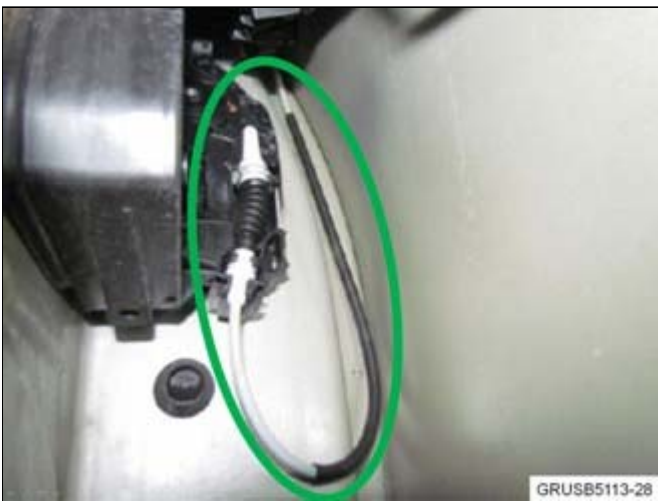
10. The Bowden cable for the outside door handle (inside door shell) must be routed in the same manner. Note: The cable shown has a smooth downward then upward loop.
