Blower Makes an Unusual Noise

F30

NEW Produced from May 31, 2011 to February 13, 2013

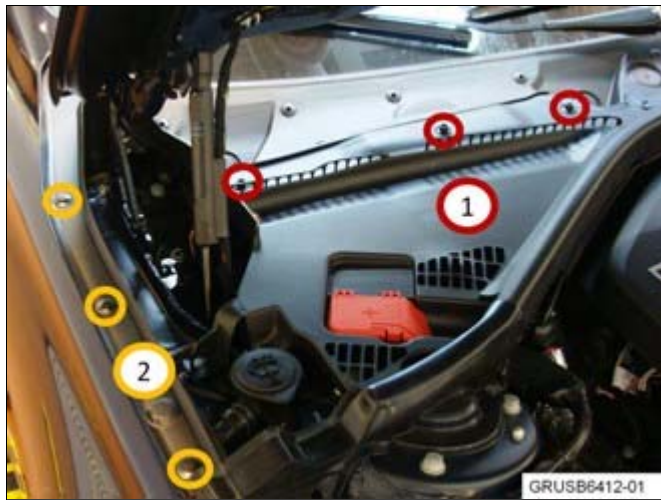
| | <ol style="list-style-type: none"> NEW Remove the cover (1) by loosening the three fasteners circled in red, and then remove the side panel trim piece (2) by |

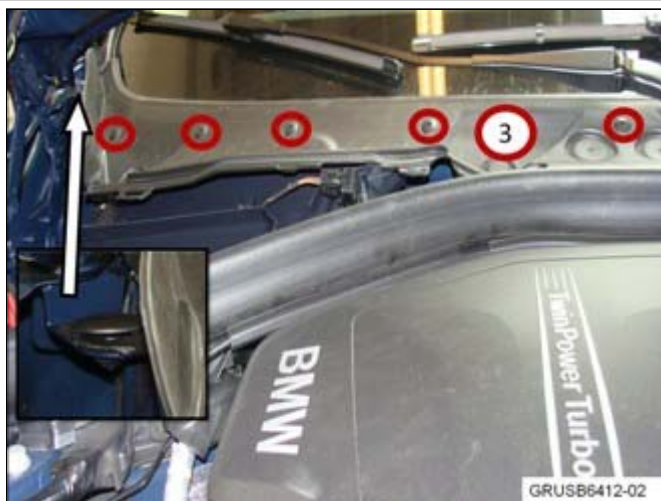
7. **NEW** The windshield cowl panel (3) must be loosened to better access the fresh air intake cover. Release the five fasteners circled in red, and then remove the expanding rivet shown by the white arrow.

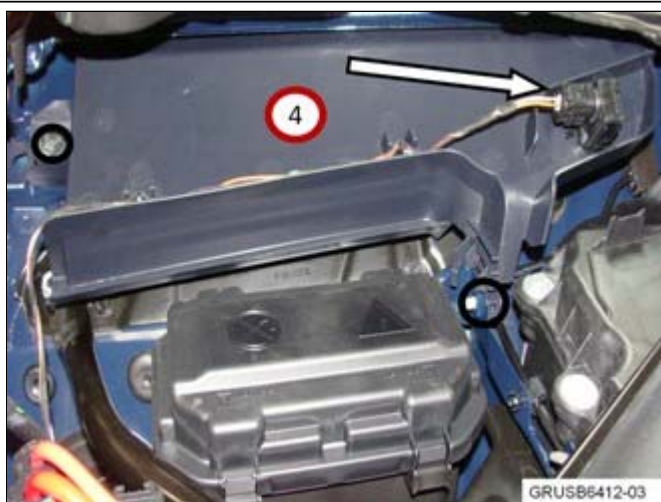
8. **NEW** The fresh air intake cover (4) must be removed. Disconnect the sensor shown by the white arrow and remove the two fasteners circled in black.

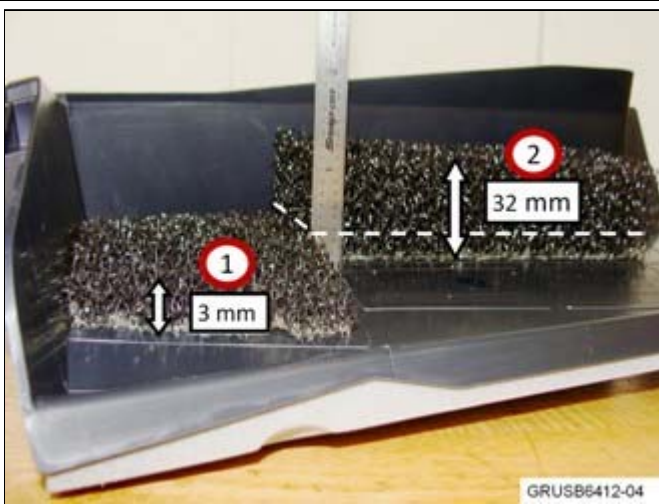
9. **NEW** Inspect the underside of the removed fresh air intake cover. The two foam pieces attached confirms it has the early version kit installed. Remove these two foam strips.

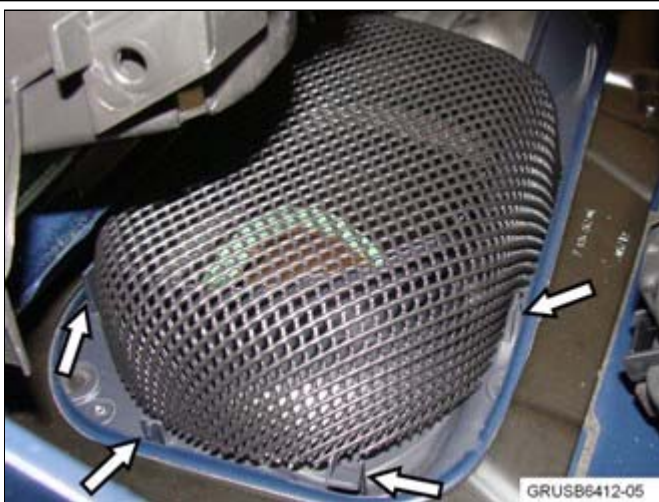
10. **NEW** The basket (P/N 64 31 9 296 394) must also be removed and discarded. After removal, be certain to check and remove all remaining debris, such as leaves and sticks, from the exposed area of the blower opening.
11. **NEW** The next step describes the installation of the new repair screen.

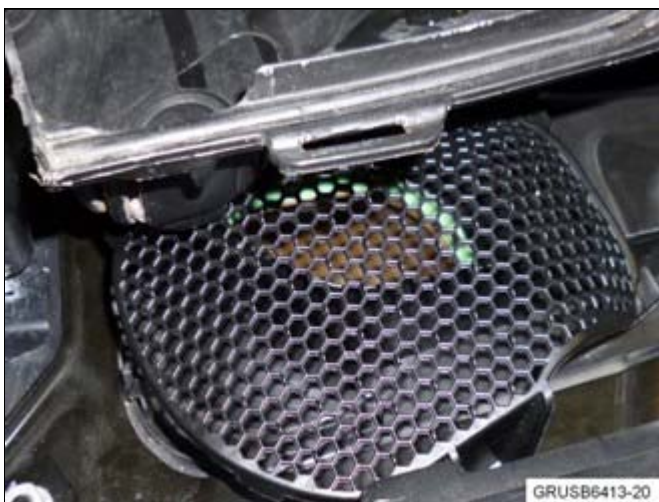
12. **NEW** The new repair screen (P/N 64 31 9 321 616) contains a more robust honeycomb grid that provides better protection from debris. Fit the new screen over the blower opening and rotate underneath the cowl.

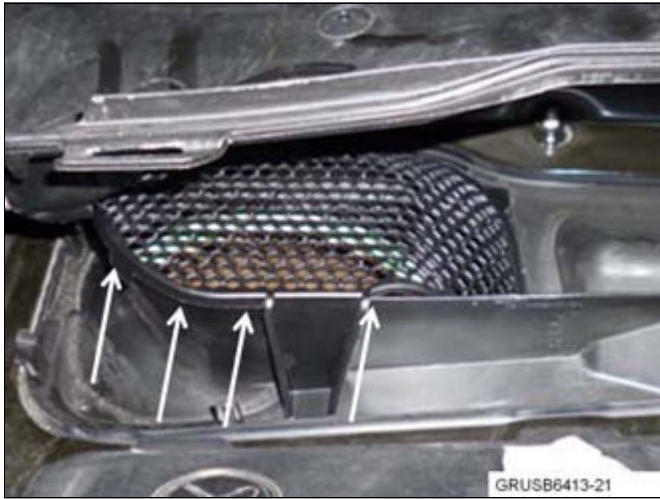
13. **NEW** Check for proper fitment of the screen and ensure it is properly fitted to the upper dividing wall, as shown by the white arrows.
