SUBJECT

“Message” Option Is Missing After Programming

MODEL

With option 609 (Navigation System, Professional)

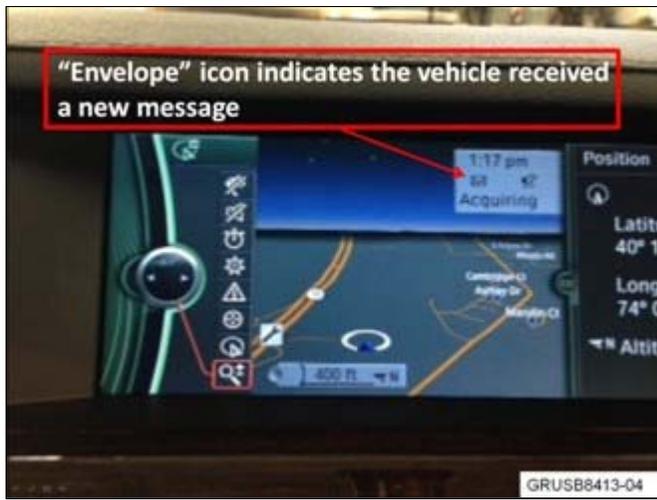
| | <ol style="list-style-type: none"> 2. This picture shows that a new message is received by the vehicle. <p>Note: The envelope icon can be seen in any of the displays (radio, multimedia, etc.).</p> |

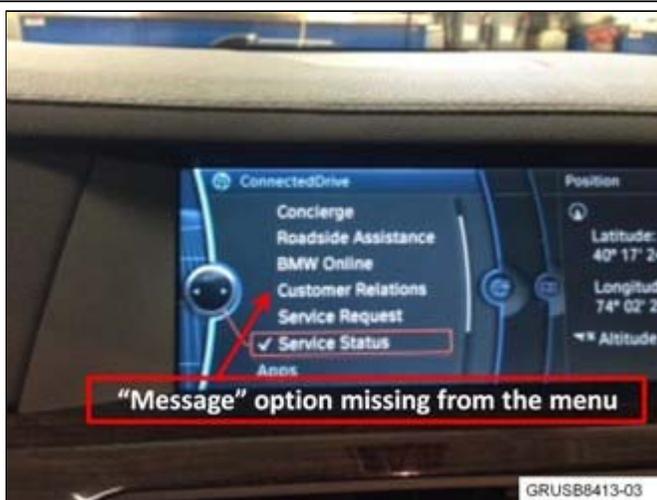
3. This picture shows the ConnectedDrive menu with no “Message” option.

4. Program the vehicle using ISTA/P 2.50.2 or higher. The new I-level F001-13-07-503 or higher.
