## BMW Motorrad USA

### Service Information Bulletin

**Subject:** Speedometer

**Models:** R 1200 GS (K50, 0A01, 0A11)

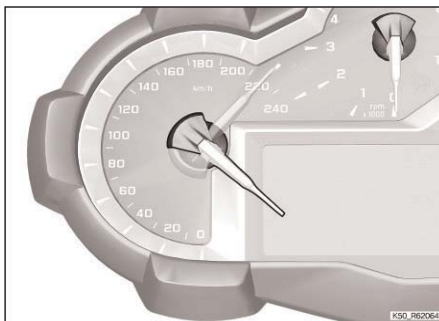
**Details:** BMW Motorrad has ascertained that on account of production process, the needle of the speedometer can turn out of position on its shaft. If this happens the needle is no longer in its zero position after the ignition has been switched off.

**Vehicles affected:** This fault can occur on R 1200 GS (K50, 0A11) models manufactured before May 27, 2013.

Example of Speedometer needle not  
in zero position

**After-sales solution:** In the event of a verified customer complaint, install a new instrument panel. See the latest RSD DVD (Repair and Service Data BMW Motorrad) for descriptions of the work items.
