2012FA06D  
May, 2013  
Product Code(s): 63  
Page 1 of 4

**SUBJECT:** Calibration Update for Improved C5 Clutch Operation with C5 Clutch Friction Plate Replacement

**MODELS AFFECTED:** 1000 and 2000 Series Transmissions

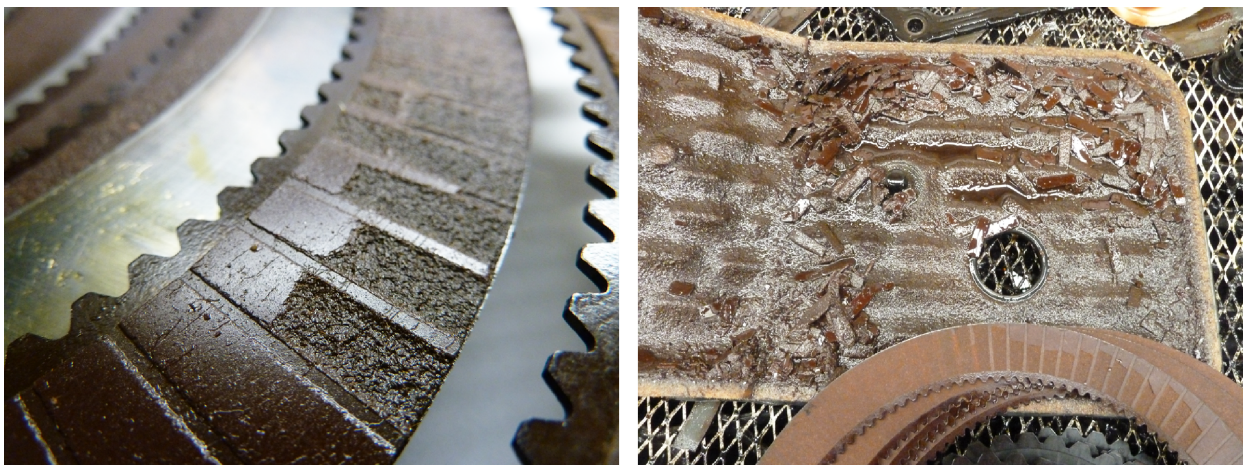
**Figure 1.**

Remove the transmission from vehicle. Remove the pan and suction filter from the transmission. Split the suction filter apart and inspect for C5 clutch debris in the pan and filter media. Refer to [Figure 1](#) for an example of debris. If C5 clutch debris is found, then continue the disassembly. Rebuild the transmission using the instructions provided in the 1000/2000 Product Families 2010 Uprate Service Manual (SM5818EN).

If C5 clutch debris is not found, then disassemble the transmission using the instructions provided in the 1000/2000 Product Families 2010 Uprate Service Manual (SM5818EN) to replace only the C5 clutch friction plates. It is necessary to partially disassemble the transmission to allow for proper selective reaction plate selection in the C5 clutch.

Install new C5 clutch friction plates, measure for proper selectable C5 reaction plate and reassemble the unit per 1000/2000 Product Families 2010 Uprate Service Manual (SM5818EN). Reinstall the transmission in the vehicle. If recalibration described in 2012FA06B has not yet been completed then reflash the updated/newest version of the original calibration as follows:
