| <b>Countries:</b> | CANADA, UNITED STATES | <b>Document ID:</b> | IK0100032 |

**Title: TerraStar Frame Reinforcement Excessive Gap Variance**

**Applies To: TerraStar Chassis**

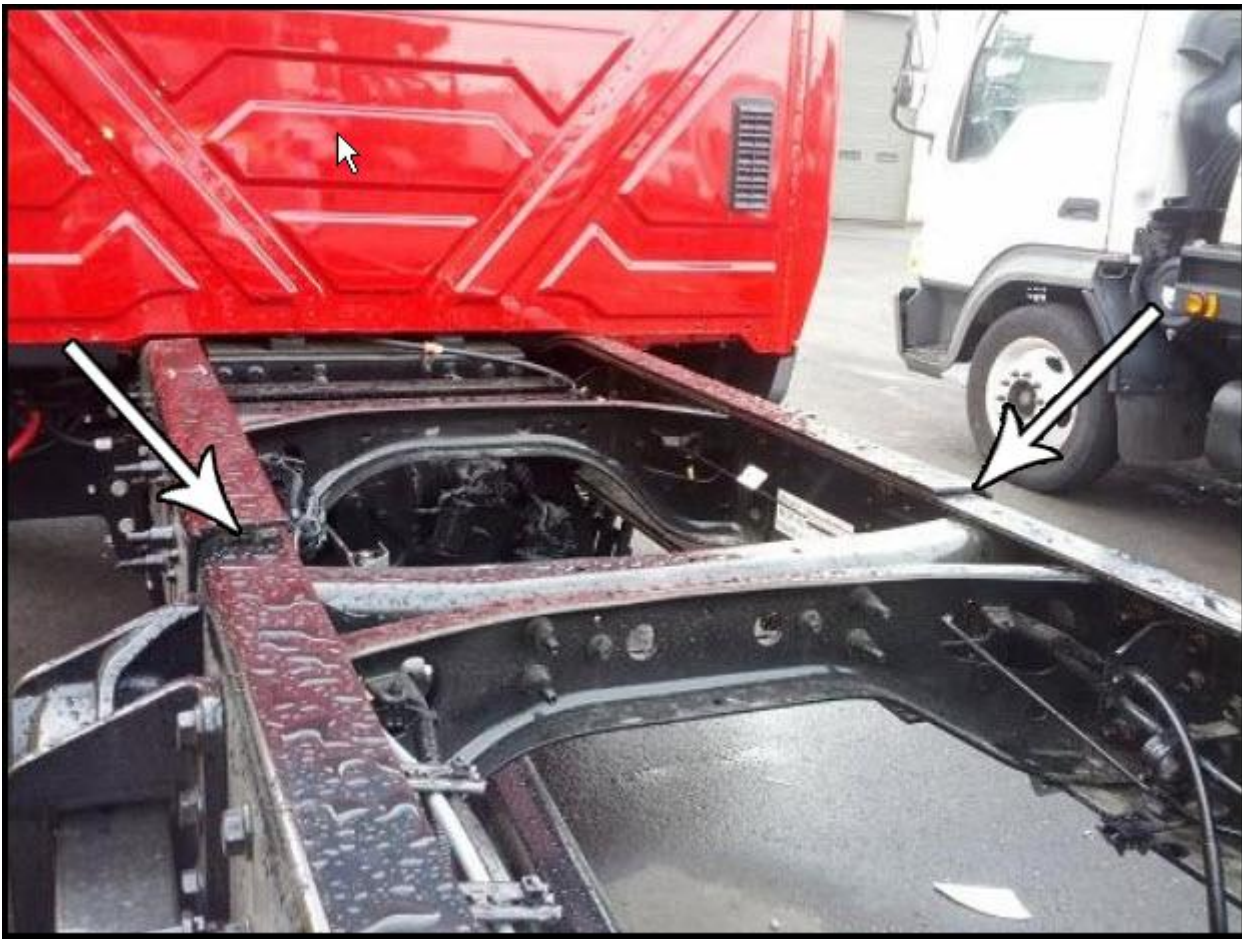
Rienforcement Frame

During frame assembly the outer reinforcement was sometimes not held even on both sides prior to fastener torquing

If the gap is larger than 1/4 inch variance from one side to the other and it is necessary for the installation of the body then the highest side reinforcement should be lowered to match the lower side. This will require most or all of the fasteners to be removed, reposition the reinforcement and refasten using the same fastener types as removed.

***NOTE – In the event that Huck fasteners are removed, in order to maintain the same joint integrity, International requires that new Huck fasteners be used for attachment/reattachment of components, unless instructed otherwise by International service documentation.***
