**Document ID:** IK0200011

**Major System:** BRAKES

**Title: Meritor Front Brake Return Spring Install**

**Applies To: ProStar, PayStar, TransStar, DuraStar, WorkStar LoneStar, Euro III 9800 RHD with 16 inch Meritor brakes**

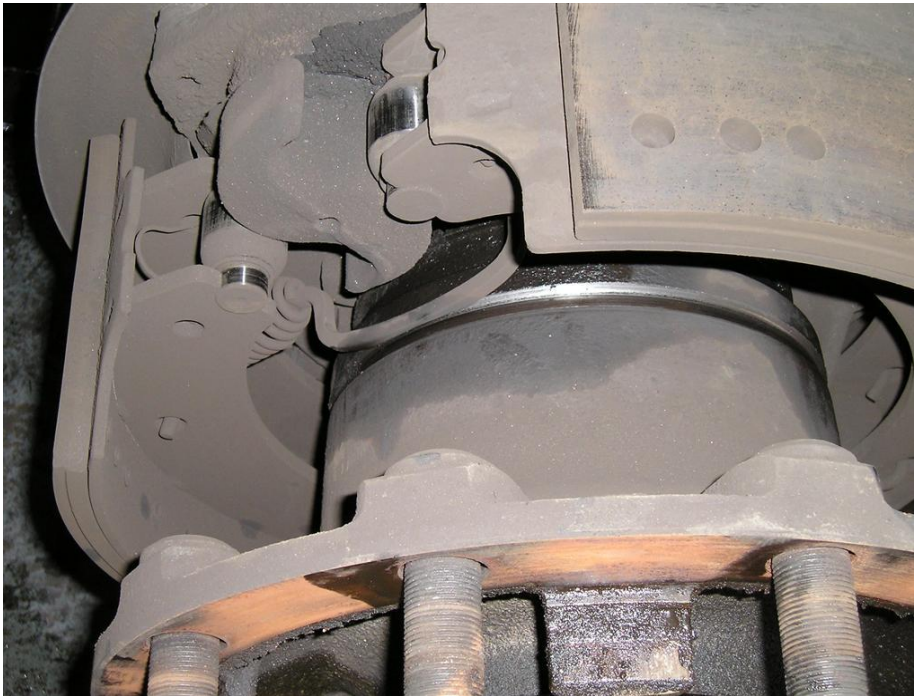
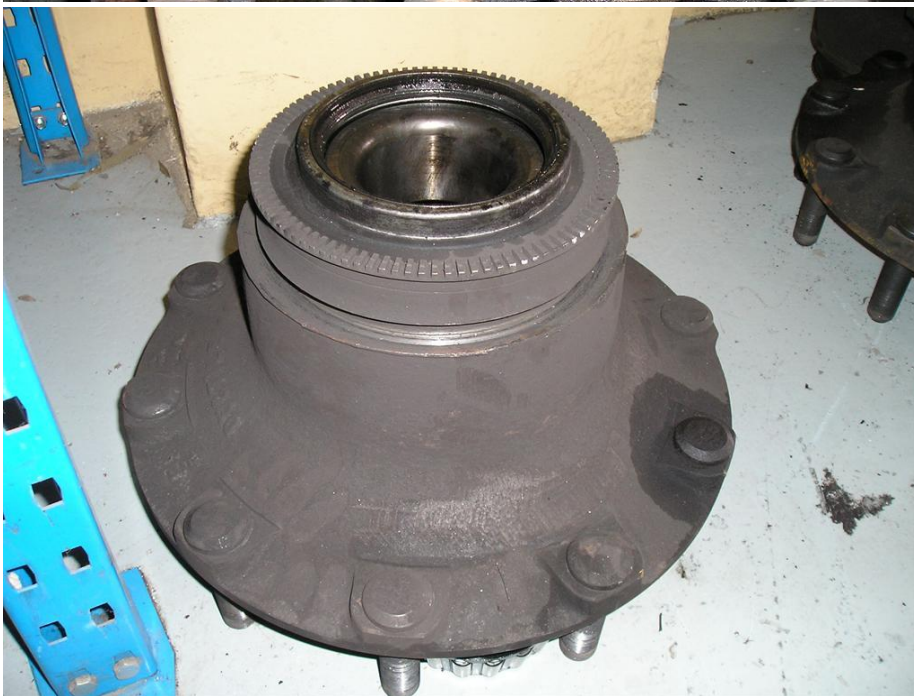
Improper installation of the brake return spring will not provide proper clearance between the return spring and the wheel hub allowing for metal to metal contact between the two components. The harder spring steel cuts through the cast steel or aluminum of the wheel hub, as seen below

Remove the front wheels and drums and check for the following condition as shown in the figures below.

This spring can be installed 4 ways and only 1 position is correct. Click [Visual Aid attachment](#) for identification of correct orientation
