Title: DPFDP Sensor Tube Thread Repair Procedure

Applies To: 2007 and Later MaxxForce DT, 9, 10

Preliminary DPFDP Sensor Tube Thread Repair Procedure

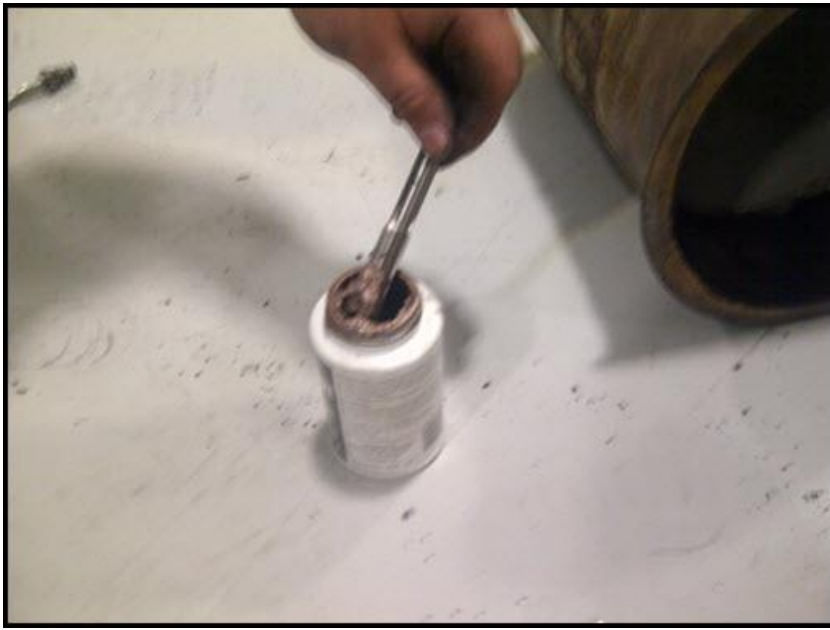
Figure 1: Coat the Flutes

Issue: When removing DPFDP sensor tubes, threads from the fitting may strip.

1. Coat the flutes of an M14X1.5 Bottoming Tap with a high temp (2000F) anti-seize compound (*Figure 1*). This will help keep metal debris from falling in the DOC or DPF and ease the thread repair procedure.
