Document ID: IK0800442  
Revision: 0  
Created: 7/11/2013  
Last Modified: 8/22/2013  
Author: Gregory Mackey

**Title: Auxiliary Battery Box - Cover Difficult to Remove****Applies To: Prostar or any vehicle with Feature Code 0008XGG (auxiliary battery box)****DESCRIPTION**

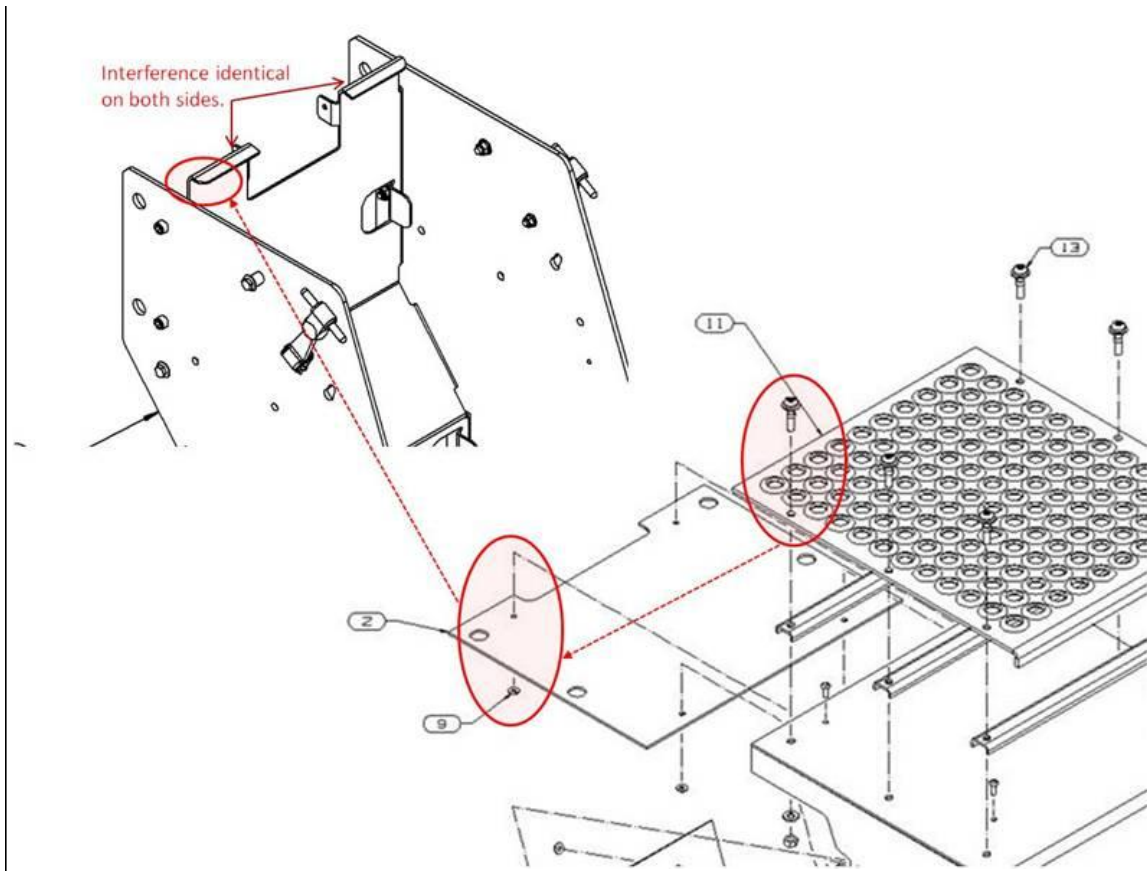
An interference condition can occur between cover bolts or step plate and a flange on the back plate of the battery box. This document describes the condition and remedy of replacing the existing bolt with a shorter bolt to eliminate the interference condition.

Figure 1 - Replace bolts causing the interference

Replace 2 - 3804756c1 M8x35mm bolts indicated as item 13 in Figure 1 w/ 2 - 3588153c1 M8x30 bolts.
