| <b>Countries:</b> | AUSTRALIA, BRAZIL, CANADA, UNITED STATES, MEXICO, SOUTH AFRICA | <b>Document ID:</b> | IK1200261 |

**Title: Battery Box Located Clean Power Fuses for the IDM (Injector Drive Module), ECM (Engine Control Module), and TCM (Transmission Control Module) Failing**

**Applies To: DLC II (EGR) International Engines**

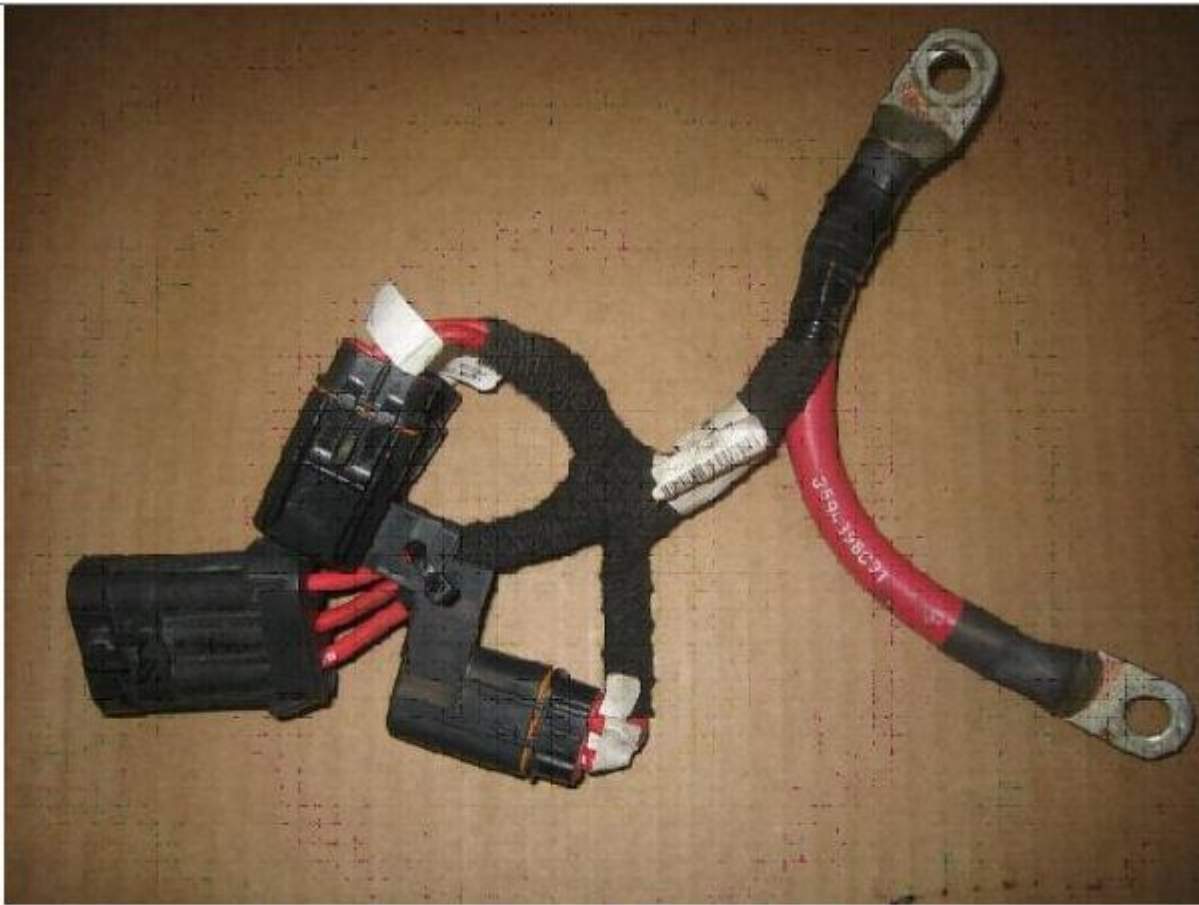
Figure 1. Jumper Cable Assembly - Typical

Service replacement part number varies based upon vehicle platform, build date, engine, and transmission configuration. Utilize the VIN parts breakdown inside the Service Parts Catalog. (Figure 1 shows a typical jumper cable assembly).

The newly released jumpers built with copper beryllium terminals have been released in the parts system. All of the old jumper harnesses have been purged from the PDC's. So, if you order a new jumper harness from the PDC, you will get the updated harness.

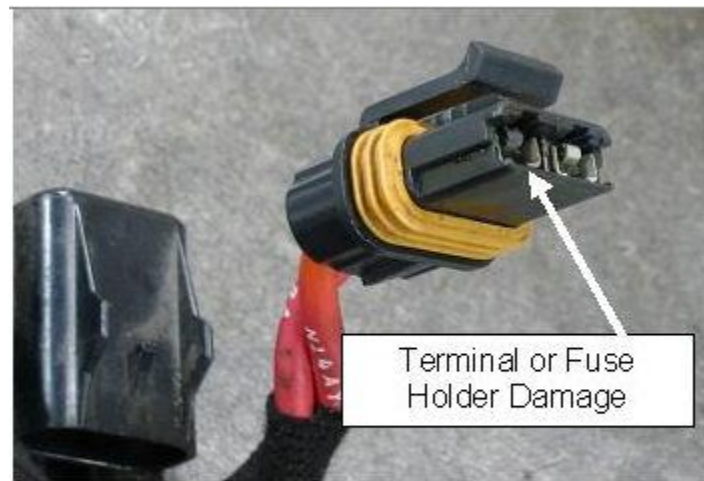
Figure 2.

1. Pull fault codes from both the engine and transmission. Hard start / no start issues can be a result of problems with power to the ECM, IDM, or TCM (not applicable for manual transmissions). The transmission controls a crank inhibit relay that will inhibit cranking if the transmissions interlocks (such as being in neutral) are not satisfied, the TCM does not have adequate power, or if active fault codes exist that are deemed necessary to resolve prior to starting the vehicle.
2. Inspect all fuse holders inside the battery box for spread fuse holder terminals, the fuse blades not fitting securely inside the mating terminals, evidence of damage to the terminals (Figure 2), or damage to the fuse itself (Figure 3). If the fuse holder(s), terminals, and fuse(s) appear good, and the fuse fits securely inside the holder, then further diagnostics and troubleshooting will be required.

3. If evidence of a damaged jumper cable assembly is found, it will need to be replaced with a new jumper cable assembly as specified in the parts information section. Two improvements have been implemented to insure the integrity of these connections. July 2007: Manufacturing process change to prevent the fuse holder terminals from being spread during the assembly and end of line testing. Dec 2007: The terminals were changed from tin plated copper to copper beryllium. The copper beryllium terminals provide an improvement in their ability to retain spring force on the fuse blades as well as having a higher resistance to thermal cycling.
