**Document ID:** IK1200471  
**Revision:** 4  
**Created:** 3/9/2010  
**Last Modified:** 8/26/2013  
**Author:** David Horner

**Title:** MaxxForce® 11 and 13 Engine Harness Rubbing Oil Dipstick Tube

**Applies To:** 2008- 2009 MaxxForce® 11 and 13 Engines

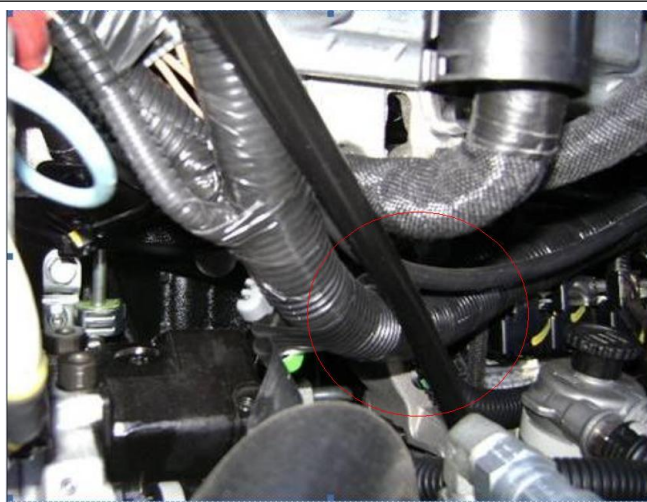
- Engine may have intermittent issues and diagnostic codes and /or intermittently trip the ECM Circuit Breaker or Fuse.

Visually inspect for rubbing/chaffing of the engine harness at the engine oil dipstick tube.

**Photo 1 - Harness contact with Dipstick Tube**

If no damaged has occurred secure the harness away from the dipstick tube using tie straps and hose guide part number 3804604C1 as illustrated in the photo below. If damage has occurred start a case file through Tech Services and attach pictures of damage so the appropriate plan of action can be determined.

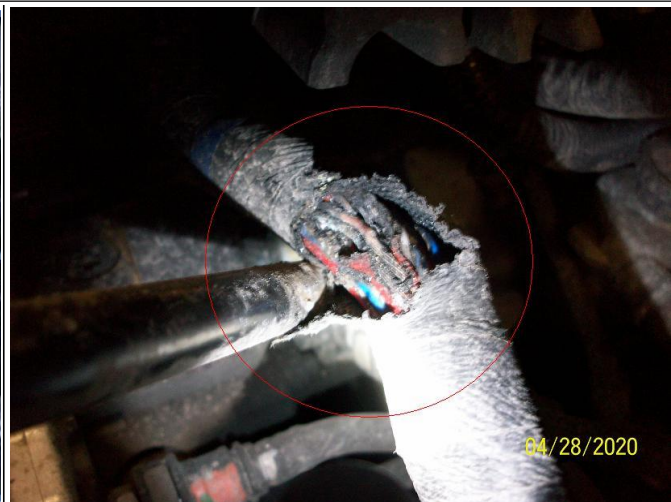
**Photo 2 - Example harness and wire damage**
