Countries:	RUSSIA, AUSTRALIA, CANADA, UNITED STATES, MEXICO	Document ID:	IK1200838
Availability:	ISIS, FleetISIS	Revision:	1
Major System:	ENGINES	Created:	11/8/2012
Current Language:	English	Last Modified:	8/27/2013
Other Languages:	NONE	Author:	Jim Restemayer
Viewed:	453

Title: 2010 Emissions Pre-DOC Mounting clamp

Applies To: 2010 Emissions 11L and 13L Engines

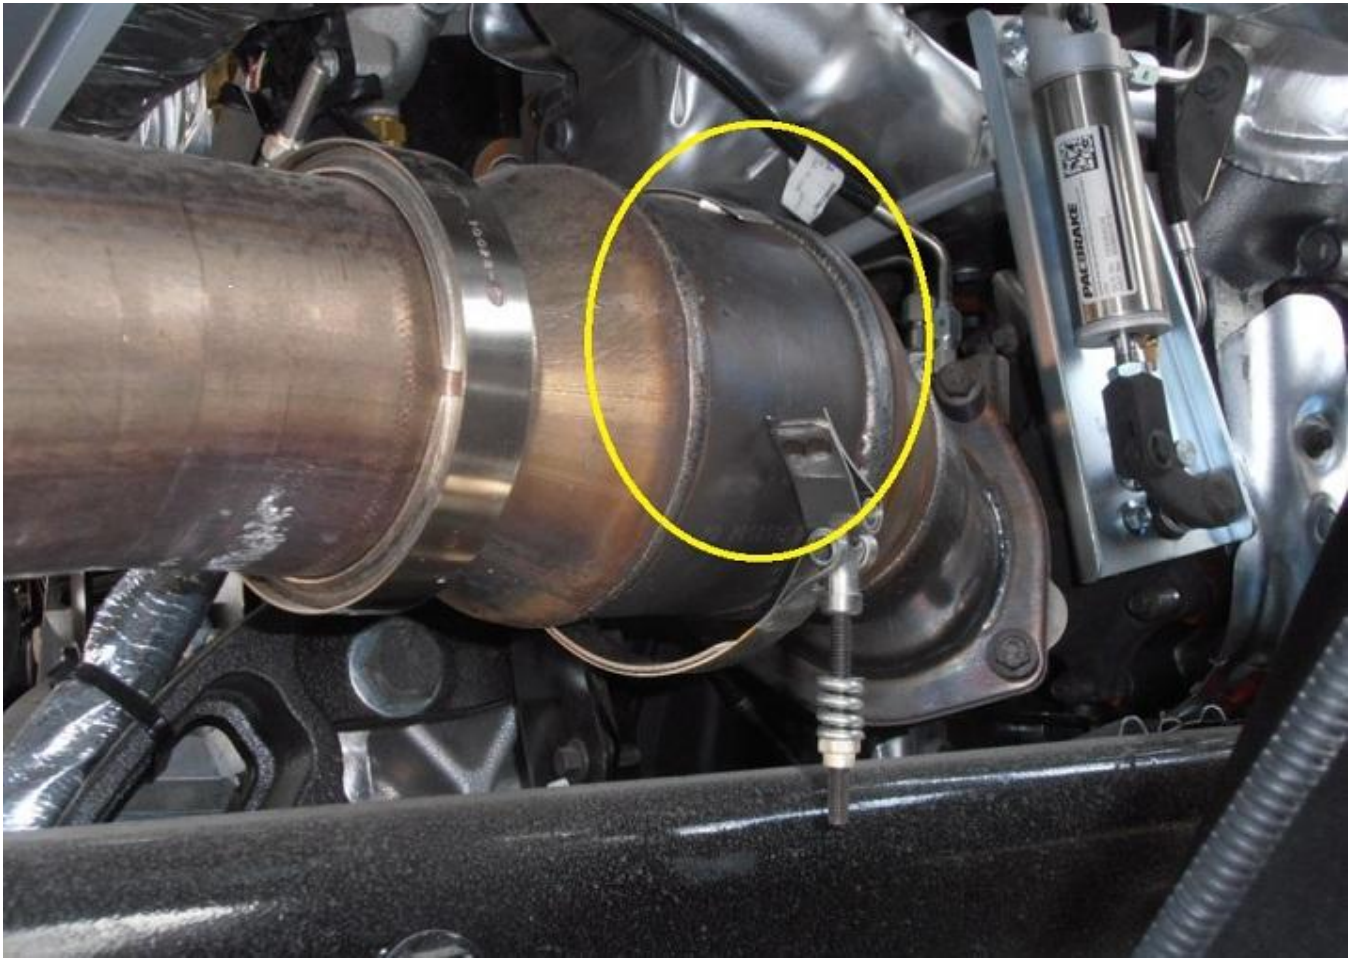
PDOC Clamp breakage

- PDOC clamp broken or missing

The mounting clamp for the Pre-DOC has been modified to be more robust and resist breakage. Units with failed mounting clamps should be upgraded to a new V-Band clamp which will need a new wide bracket to allow for the clamp to be secured. In the case that the unit has a new style V-Band clamp that fails and already has the upgraded wider bracket, simply replace the V-Band clamp.
