**Countries:** CANADA, UNITED STATES **Document ID:** IK2200061  
**Availability:** ISIS, Bus ISIS, FleetISIS **Revision:** 4  
**Major System:** BUS BODY **Created:** 1/24/2008  
**Current Language:** English **Last Modified:** 8/26/2013  
**Other Languages:** [Français](#), [Español](#), **Author:** Bob Ford  
**Viewed:** 1463

**Title: Gauge RE Ammeter Bus****Applies To: RE300 Bus Model wiith option code 16HJB**

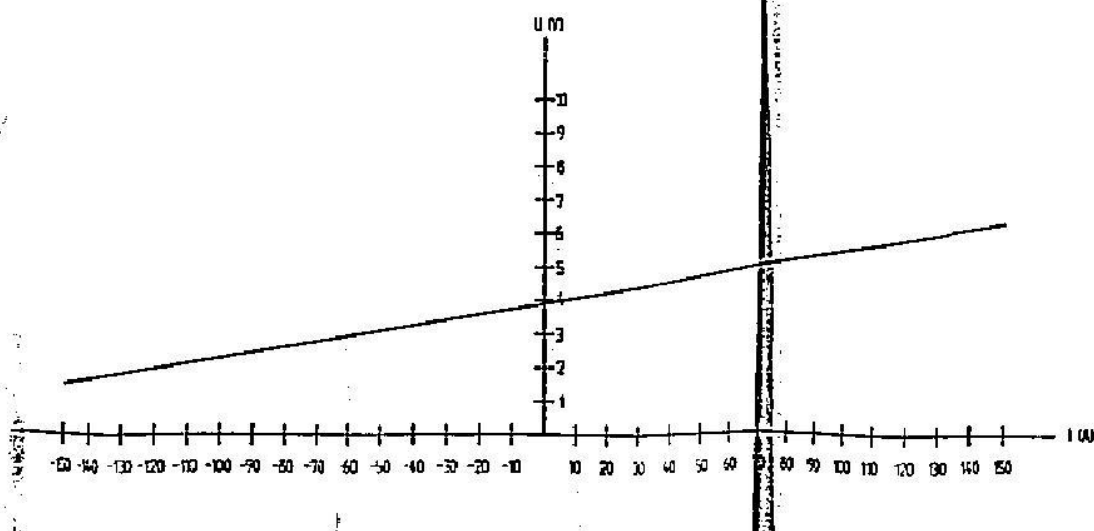
1. Voltage to cluster on circuit A26, pin 12 in connector 12 (Natural), will range from 2 to 6 volts. A voltage reading of 3.9 volts should result in a gauge reading of zero, 2 volts will result in -150 amp reading and 6 volts will result in a +150 amp reading.

Nominal output versus sensor current.

$$U = 39 + 0.016 \times I$$

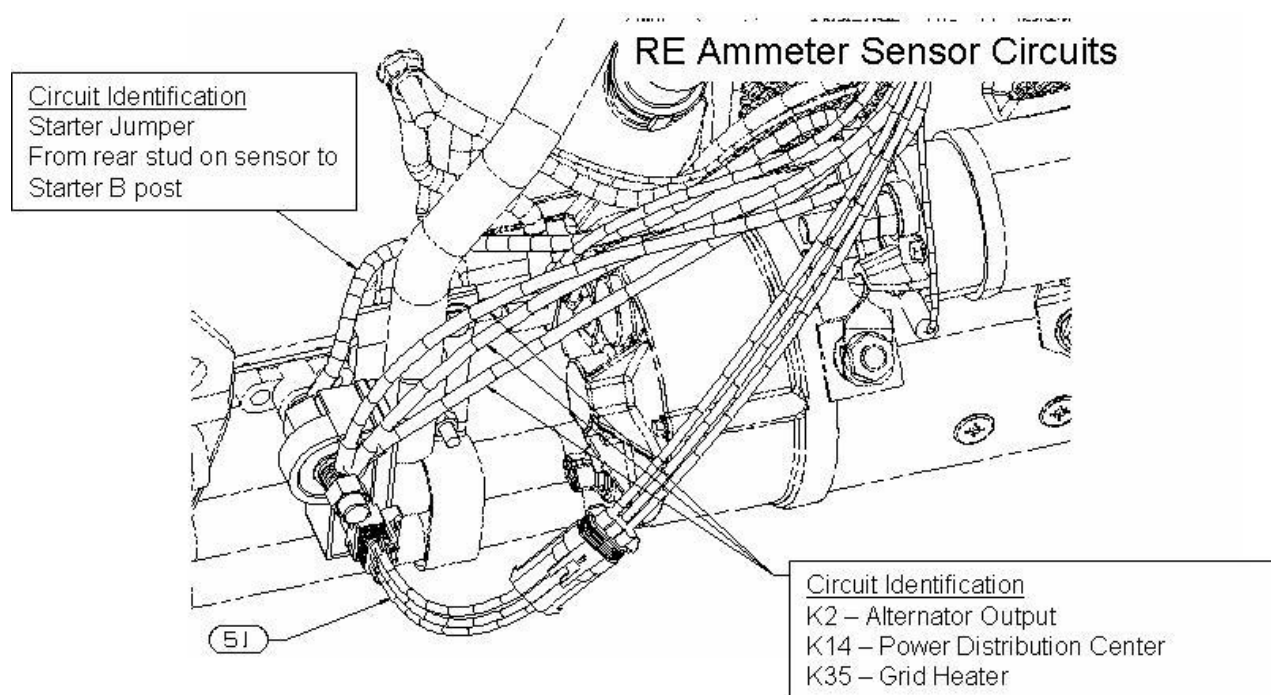
RE300 Bus model with an ammeter gauge showing a negative reading at all times may have the engine harness connected incorrectly.

Verify the required ammeter sensor circuits are properly attached. Recent cases have found the alternator output leads, K2C and K2D, connected to the starter B post rather than the sensor. If the circuits are correctly installed to the sensor, and the voltage reading on circuit A26 at the cluster is incorrect for the actual alternator output and unit load, the sensor may be at fault.
