**Countries:** CANADA, UNITED STATES **Document ID:** IK2200062  
**Availability:** ISIS, Bus ISIS, FleetISIS **Revision:** 3  
**Major System:** BUS BODY **Created:** 2/1/2008  
**Current Language:** English **Last Modified:** 8/26/2013  
**Other Languages:** [Français](#), [Español](#), **Author:** Bob Ford  
**Viewed:** 1321

**Title:** Master Disconnect and Noise Kill Solenoid Replacement

**Applies To:** IC Bus Models, BE, CE Built Prior to April 2012, RE Built Prior to Jan 2010, All FE

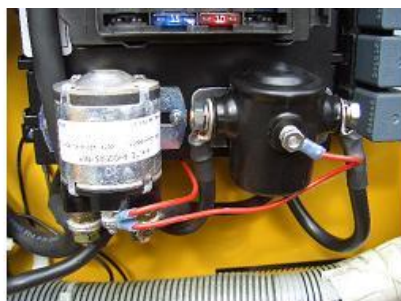
Figure 1

Original equipment power panel feed solenoids can be susceptible to moisture intrusion resulting in corrosion and intermittent operation. Original equipment solenoids can be replaced with moisture resistant sealed solenoids.

The original equipment solenoid and the moisture resistant sealed solenoid are shown in **Figure 1**. The side post design of the sealed solenoid will not allow the original mounting configuration to be used in a two solenoid configuration.
