Electric seat fore/aft adjustment nonfunctional

Topic number	LI91.10-P-054143
Version	3
Design group	91.10 Front seats
Date	07-10-2013
Validity	Model series 204, 207, 212 and 218 with fully electric seat adjustment
Reason for change	Added 204.0 and 204.9
Reason for block

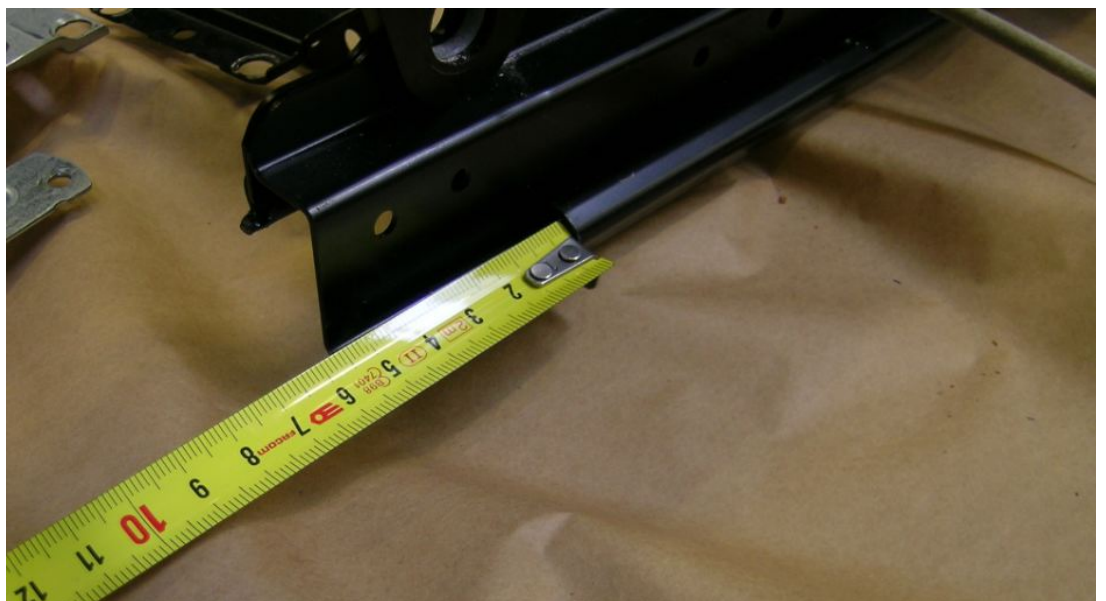
Pic11.JPG:

If the electric motor or one of the shafts has become detached as a result of the damage, it is essential to check and, if necessary, to restore the parallelism.

To do so, compare the longitudinal position of the rear edge of the respective rail using a measuring tape (Pic11) and adjust by turning the inserted shaft

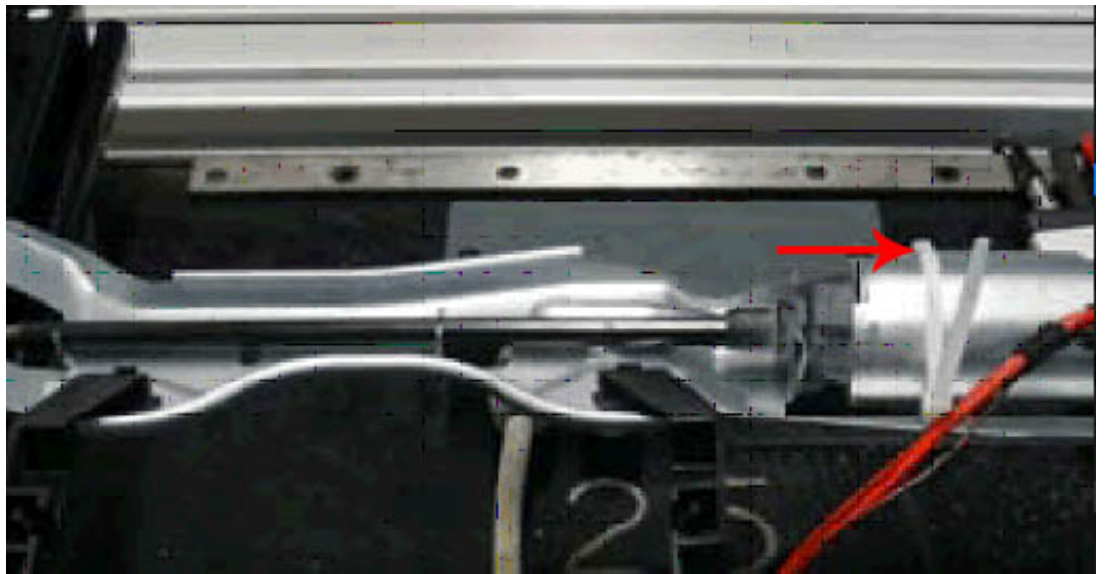
motor_reinforce.jpg:

For model 204.0 and 204.9 the entire seat frame must be replaced and seat motor should be reinforced:

The customer should be made aware that adjusting the seat with items underneath it can and will damage the seat. Replace affected seat frame (follow WIS document AR91.10-P-1450CW). To prevent this issue from occurring again, use a cable tie to secure the fore/aft motor to mounting bracket on both the new seat frame, as well as the other seat frame (as illustrated in the attached picture motor_reinforce.jpg).
