**Document ID:** IK1200416  
**Revision:** 3  
**Created:** 10/27/2009  
**Last Modified:** 3/14/2013  
**Author:**

**Title:** Dual Throttle Pedal Harness Troubleshooting

**Applies To:** 7000 4000 Models with Dual Throttle Harness and Switch Installed.

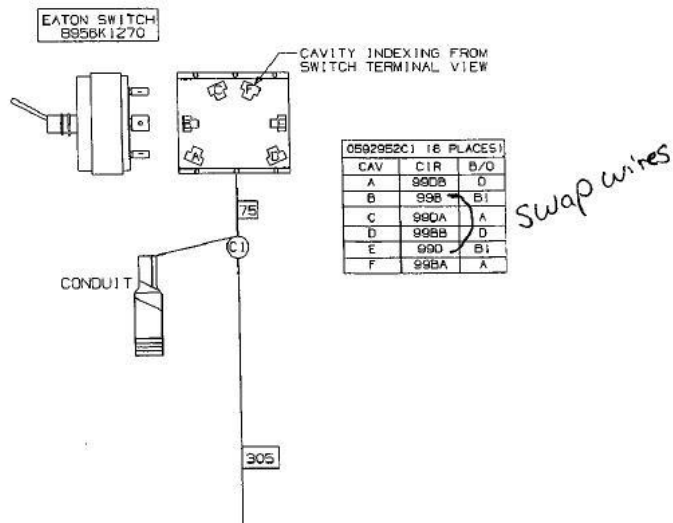
## CIRCUIT DIAGRAM

1. Check the wires on the back of the selector switch
2. Verify that wire 99B is in cavity B
3. Verify that wire 99D is in cavity E
4. If these are incorrect please swap the two wires.
5. If these wires are in the correct locations please follow the correct Iknow article for the aps troubleshooting.
