**Document ID:** IK1200753  
**Revision:** 4  
**Created:** 4/19/2012  
**Last Modified:** 3/19/2013  
**Author:** Jaime Ochoa

## Title: Hydrocarbon Injector Housing Cleaning Procedure (AFI Plugging)

Applies To: 2010 EPA MF DT, 9, 10, 11, 13, 15

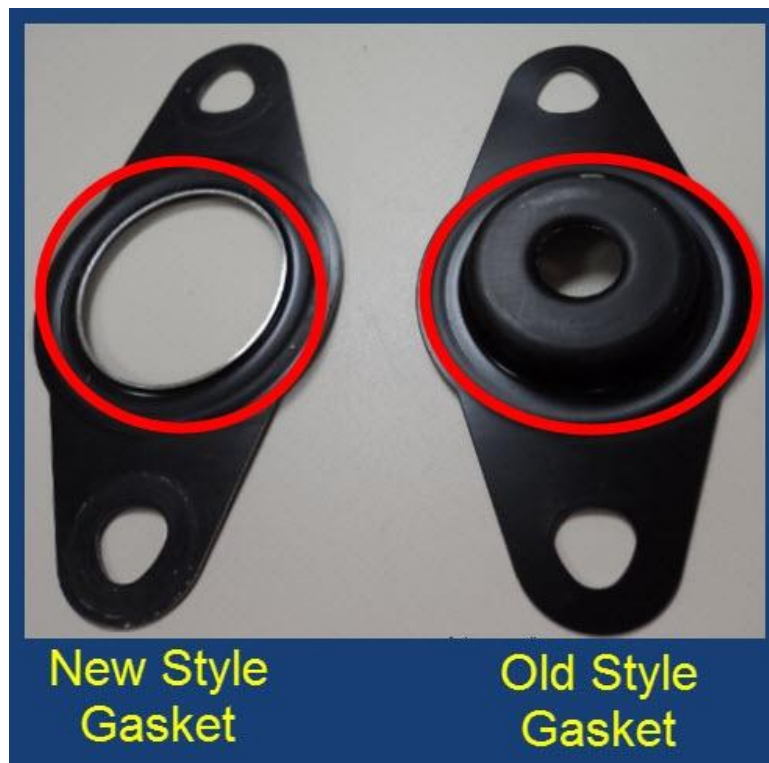
Figure 1 - Gasket Changes

The old gasket (p/n **3005521C1**) has been reworked and replaced with p/n **3018016C1**. The new style gasket will have the raised center portion of the gasket removed (Figure 1).

Replace the below gasket and bolts when servicing the HC Injector [aftertreatment fuel injector (AFI) and doser injector].

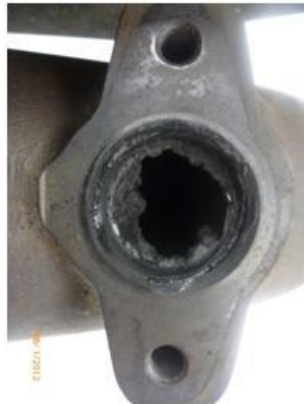
A plugged HC injector port will result in improper or frequent aftertreatment regenerations (regens). If the AFI port is plugged use this procedure and the Navistar Engine Diagnostic Manual (I6 MF DT, 9 & 10 [EGES 455](#); BB MF 11 & 13 [EGES 470](#); MF 15 [EGES 515](#)) for additional reference.

**Figure 2 – Partially plugged AFI port**

5. Remove the carbon plugging with a chisel or other appropriate tool.
6. Remove the carbon debris from the exhaust brake housing (A shop vac can be used).

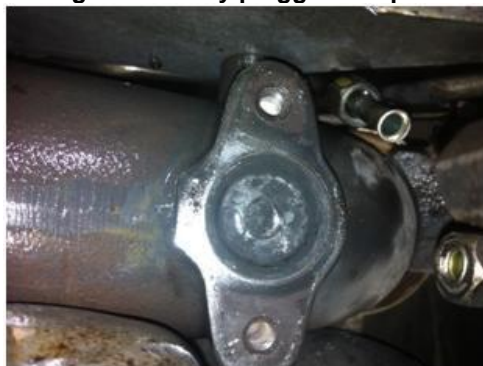
**Figure 3 – Fully plugged AFI port**

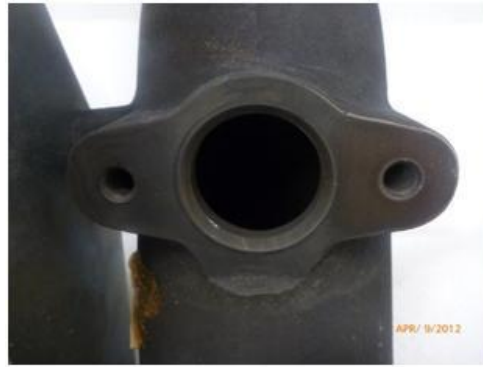
**Figure 4 – Clear AFI port**
