Countries: CANADA, UNITED STATES, MEXICO **Document ID:** IK1300134
Availability: ISIS, FleetISIS **Revision:** 1
Major System: TRANSMISSION **Created:** 3/14/2013
Current Language: English **Last Modified:** 3/22/2013
Other Languages: NONE **Author:** Matthew Boyer
Viewed: 82

Title: TerraStar Transmission Shift Cable Routing

Applies To: Terrastar Trucks

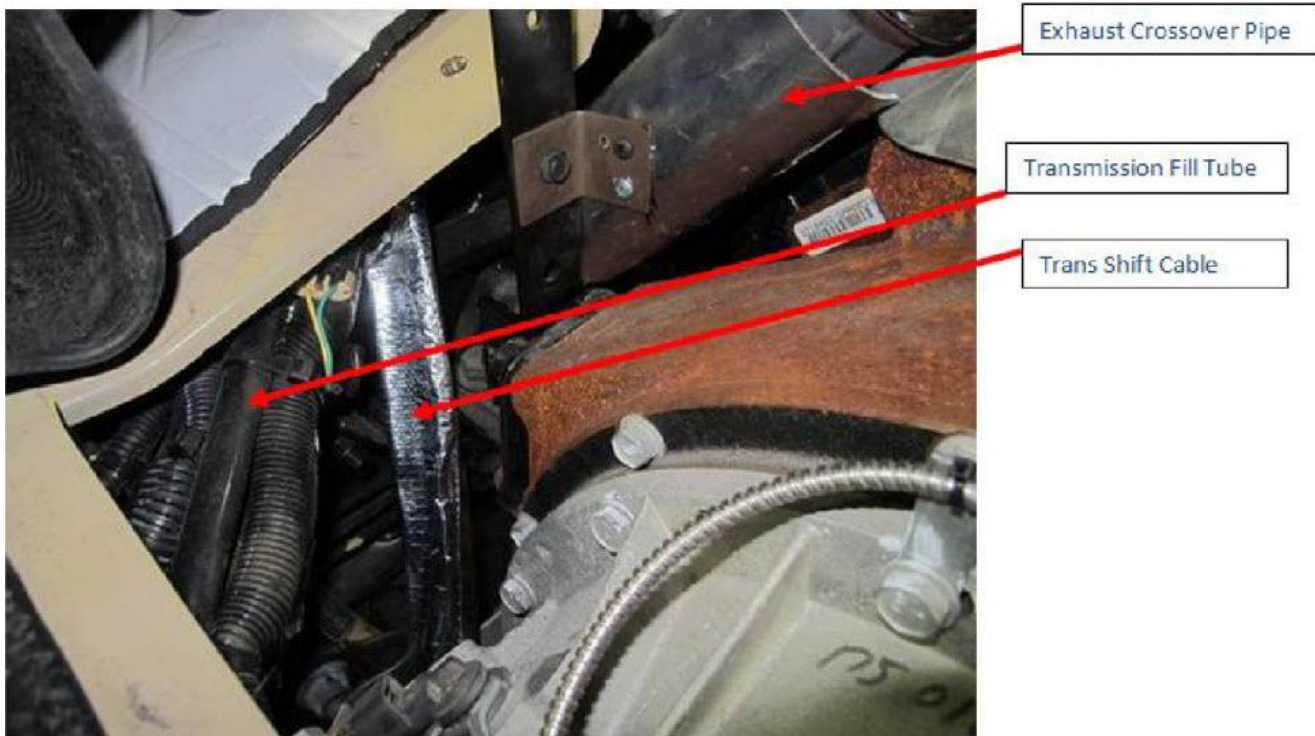
On 2010 through 2012 model year TerraStars, the shift cable may be routed incorrectly causing damage to the shift cable. This can cause difficulty selecting the desired transmission range, or if not resolved quickly, damage to the column gear shift assembly.

Incorrect Routing - Transmission shift cable is routed to the inside of the transmission fill tube.
