Countries: CANADA, UNITED STATES Document ID: IK1200655  
Availability: ISIS, Bus ISIS, FleetISIS Revision: 8  
Major System: ENGINES Created: 10/7/2011  
Current Language: English Last Modified: 2/4/2013  
Other Languages: NONE Author: Gregory Stone  
Viewed: 6103

Title: Injection Pressure Regulator (IPR) Pigtail

Applies To: MaxxForce 07-09 and 2010 DT, 9, & 10 engine builds and later (ESN 3000000 to 3999999)

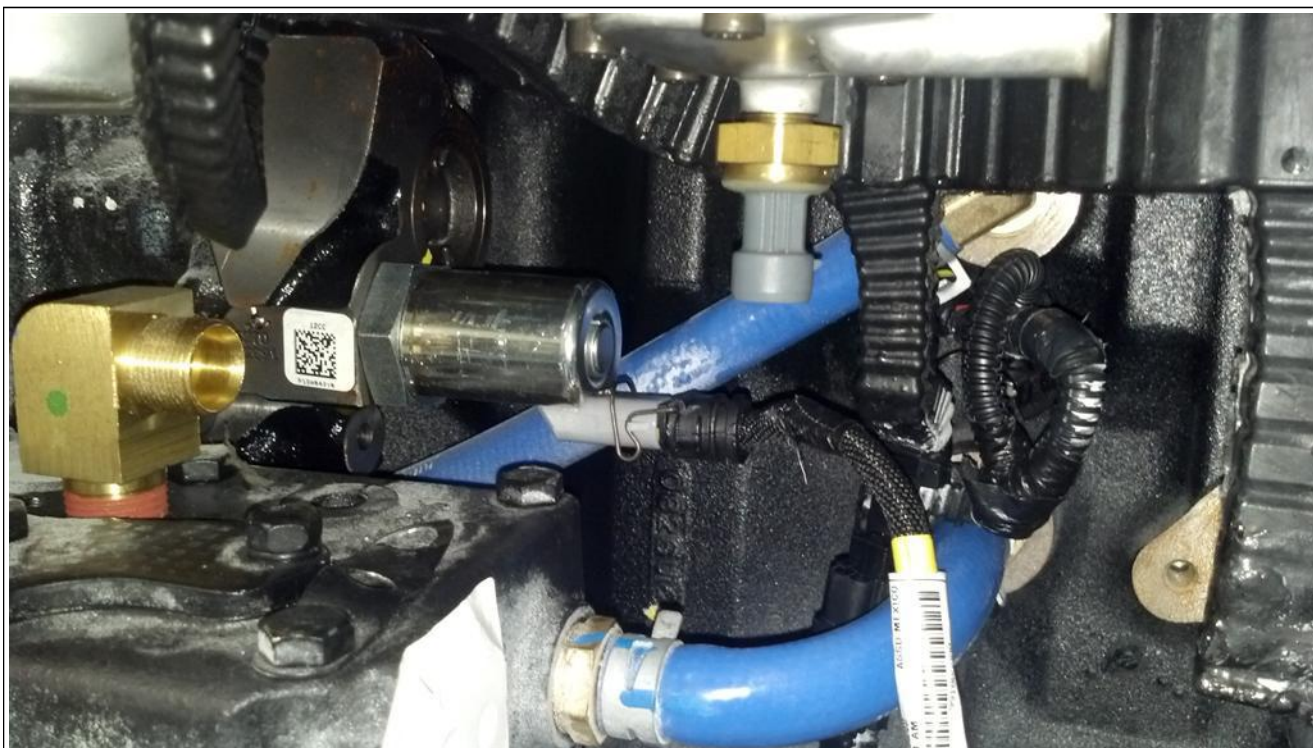
Figure 1: IPR with new connector.

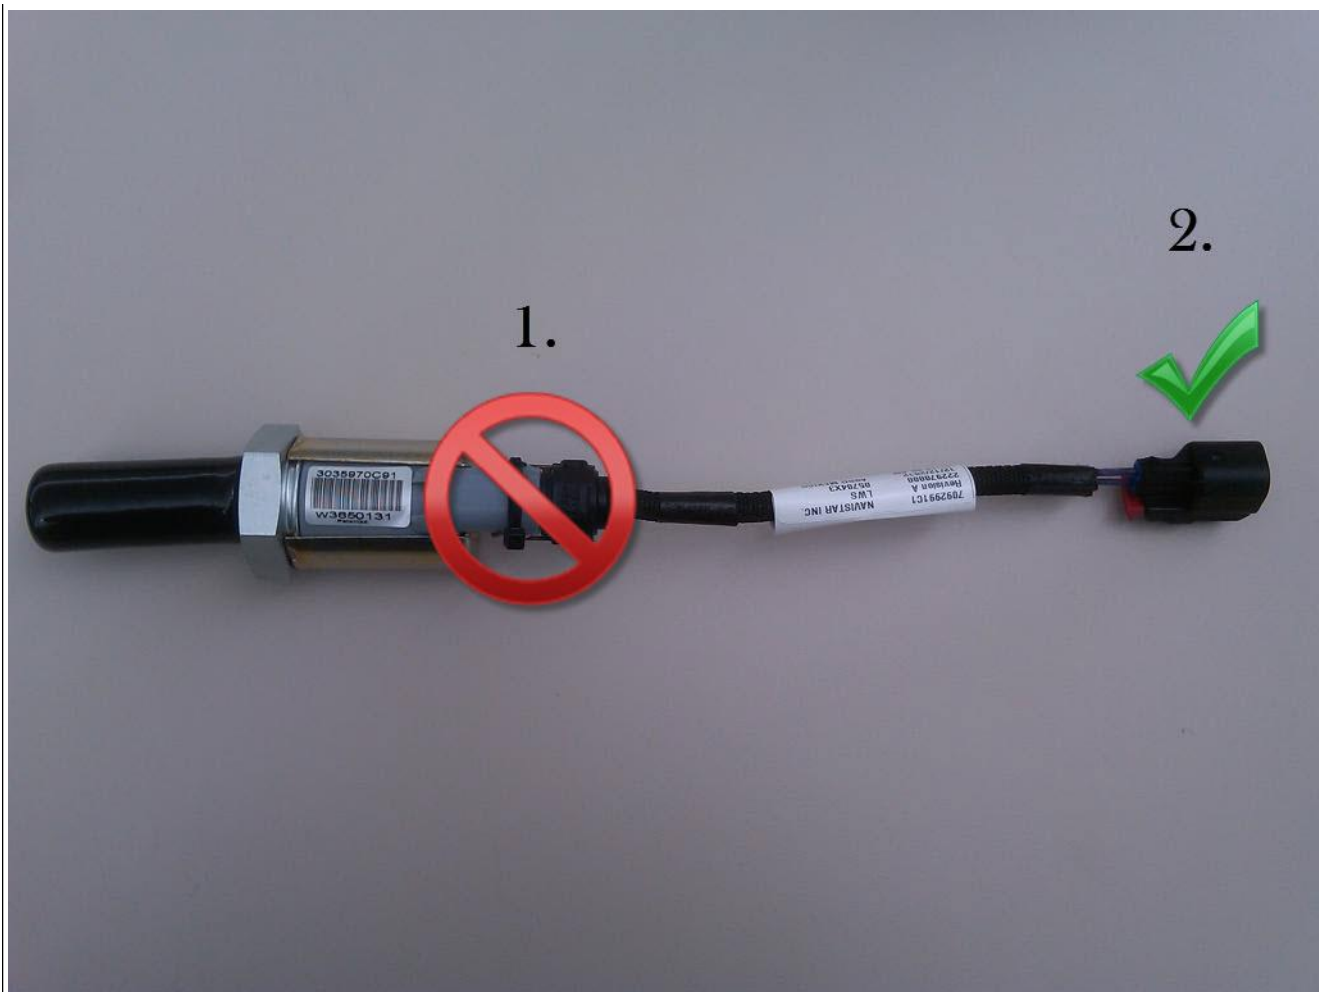
- A new IPR Kit has been released. The new style has a remote mounted connection 7 inches from the IPR valve (figure 2).
- **The connection at the IPR valve is no longer serviceable and disassembly should not be attempted (figure 2).**
- The kit includes a new IPR valve, IPR pigtail, zipties, butt connectors, convolute, and directions for installing the new IPR (figure 3).
- The IPR Solenoid needs to be clocked properly, refer to the included instruction sheet for proper installation.
- The new style IPR requires the use the new tool 12-800-01(see figure 4 below)
- Tool instructions are available on the Service Tool Resource Center (TL2900008).

**Figure 2: IPR With new connector**

1. Not servicable: Do not attempt to disconnect
2. Remote mounted connector.

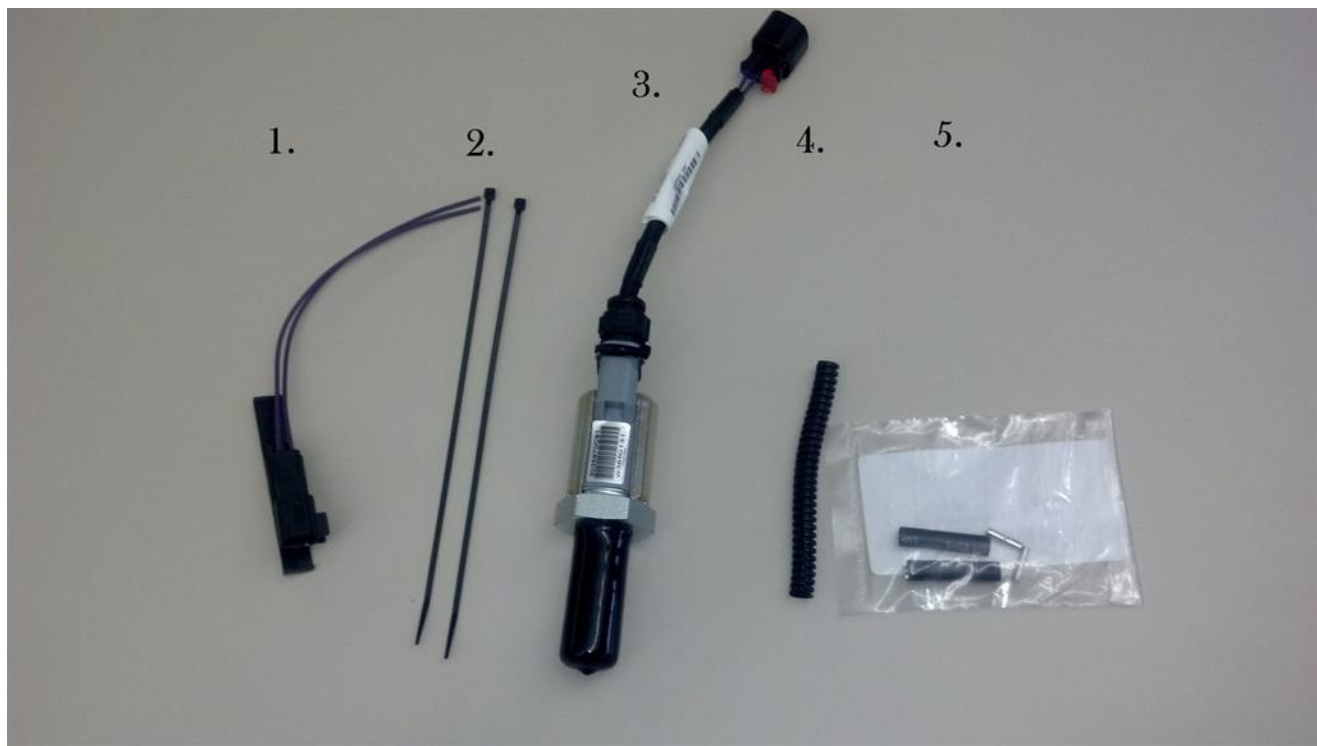
Figure 3: Kit contents

1. Pigtail
  2. Zip ties
  3. Injection Pressure Regulator
  4. Convolute
  5. Butt connectors and Heat shrink.
- (Directions not pictured)

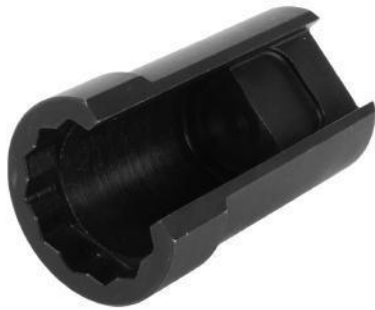
Figure 4: Glued IPR valve requires Tool # 12-800-01

Tool Number: 12-800-01

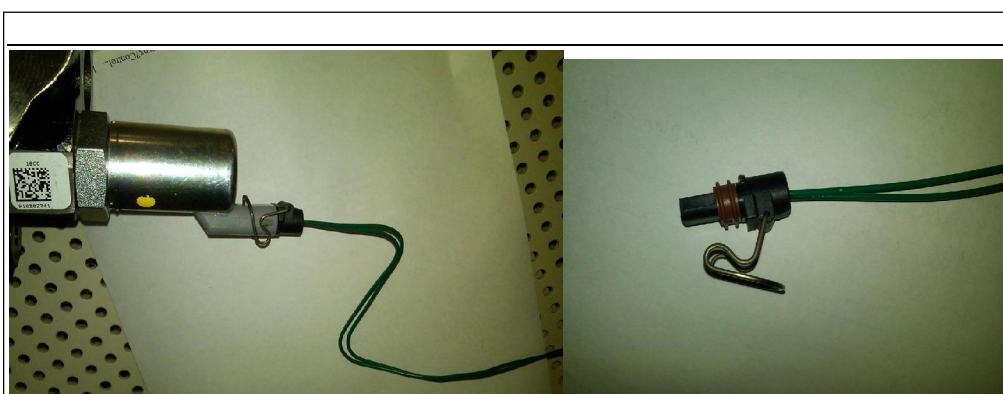
- IPR pin fretting increases resistance at IPR connection.

Figure 5: IPR pigtail and IPR Valve showing the necessary bend in the wire to prevent future fretting.

- Replace IPR valve and/or pigtail; leave generous length of wire to allow movement. The IPR pigtail service part must have a 90mm wire tail between the IPR connector and the wiring harness. See Figure 5 below.
  - Use a generous amount of Dielectric Grease.

**IPR Pigtail Part Number: 2501107C1\***
