Countries: Document ID: IK1200753
 Availability: Revision: 3
 Major System: ENGINES Created: 4/19/2012
 Current Language: English Last Modified: 2/27/2013
 Other Languages: NONE Author: Jaime Ochoa
 Viewed: 1211

Title: Hydrocarbon Injector Housing Cleaning Procedure (AFI Plugging)

Applies To: 2010 EPA MF DT, 9, 10, 11, 13, 15

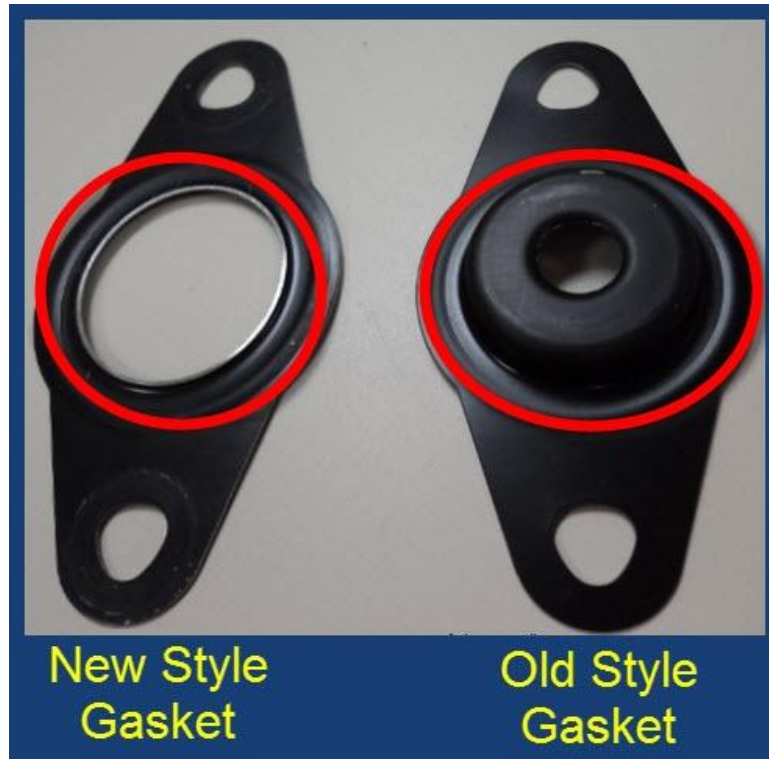
Figure 1 - Gasket Changes

The old gasket (p/n **3005521C1**) has been reworked and replaced with p/n **3018016C1**. The new style gasket will have the raised center portion of the gasket removed (Figure 1).

Replace the below gasket and bolts when servicing the HC Injector [aftertreatment fuel injector (AFI) and doser injector].

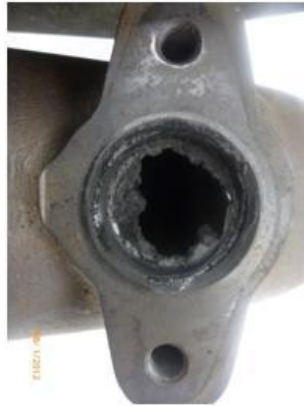
A plugged HC injector port will result in improper or frequent aftertreatment regenerations (regens). If the AFI port is plugged use this procedure and the Navistar Engine Diagnostic Manual (I6 MF DT, 9 & 10 [EGES 455](#); BB MF 11 & 13 [EGES 470](#); MF 15 [EGES 515](#)) for additional reference.

Figure 2 – Partially plugged AFI port

5. Remove the carbon plugging with a chisel or other appropriate tool.
6. Remove the carbon debris from the exhaust brake housing (A shop vac can be used).

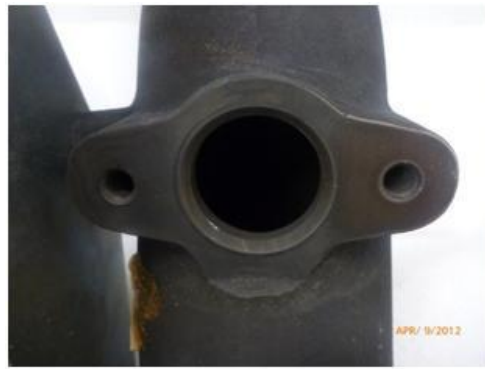
Figure 4 – Clear AFI port
