TECH TALK

Volume 193, January, 2013

Vehicle Technical Info

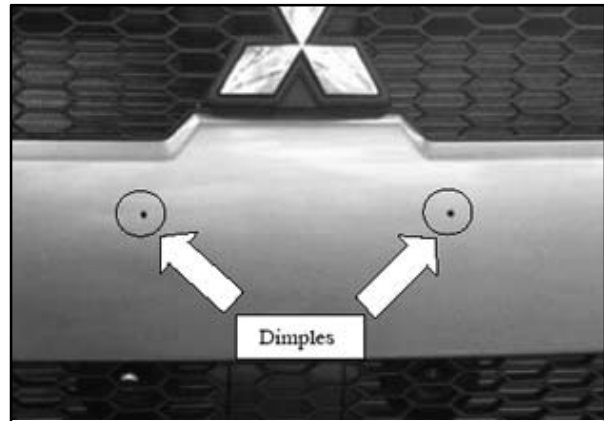
ATIN-12-42A-002: 2013 OUTLANDER, LANCER AND LANCER SPORTBACK - FRONT LICENSE PLATE HARDWARE ELIMINATED — 2013 Outlander, Lancer and

Affected vehicles are no longer being shipped with front license plate hardware (rubber nut and bolt package). Dealers are asked to use self-tapping screws for mounting the front license plate. License plates should be installed in the locations indicated by dimples in the front fascia. Dealers should use locally sourced, non-corroding, M6 fasteners, 15mm to 25 mm long. Fasteners should be installed using hand tools only.

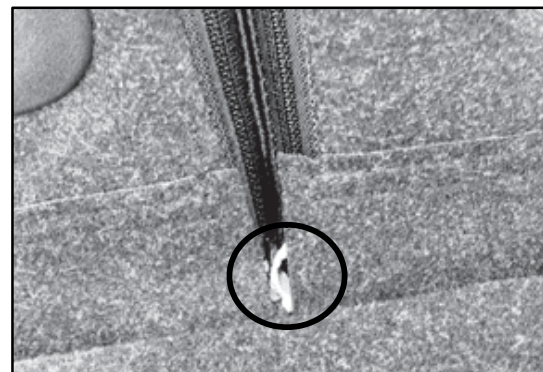
EXPOSED FOAM PADDING NEAR REAR SEATBACK SPLIT — 2013 Outlander Sport. If exposed foam padding is visible near the seat back 60/40 split, simply grasp it between your fingers and remove it. This material is molding flash that was not properly trimmed and can be discarded.
